Our Ref: P9013/LET-1

**RE: Groundwater Monitoring Completion Letter Report for Land off Workhouse Lane, Burbage**

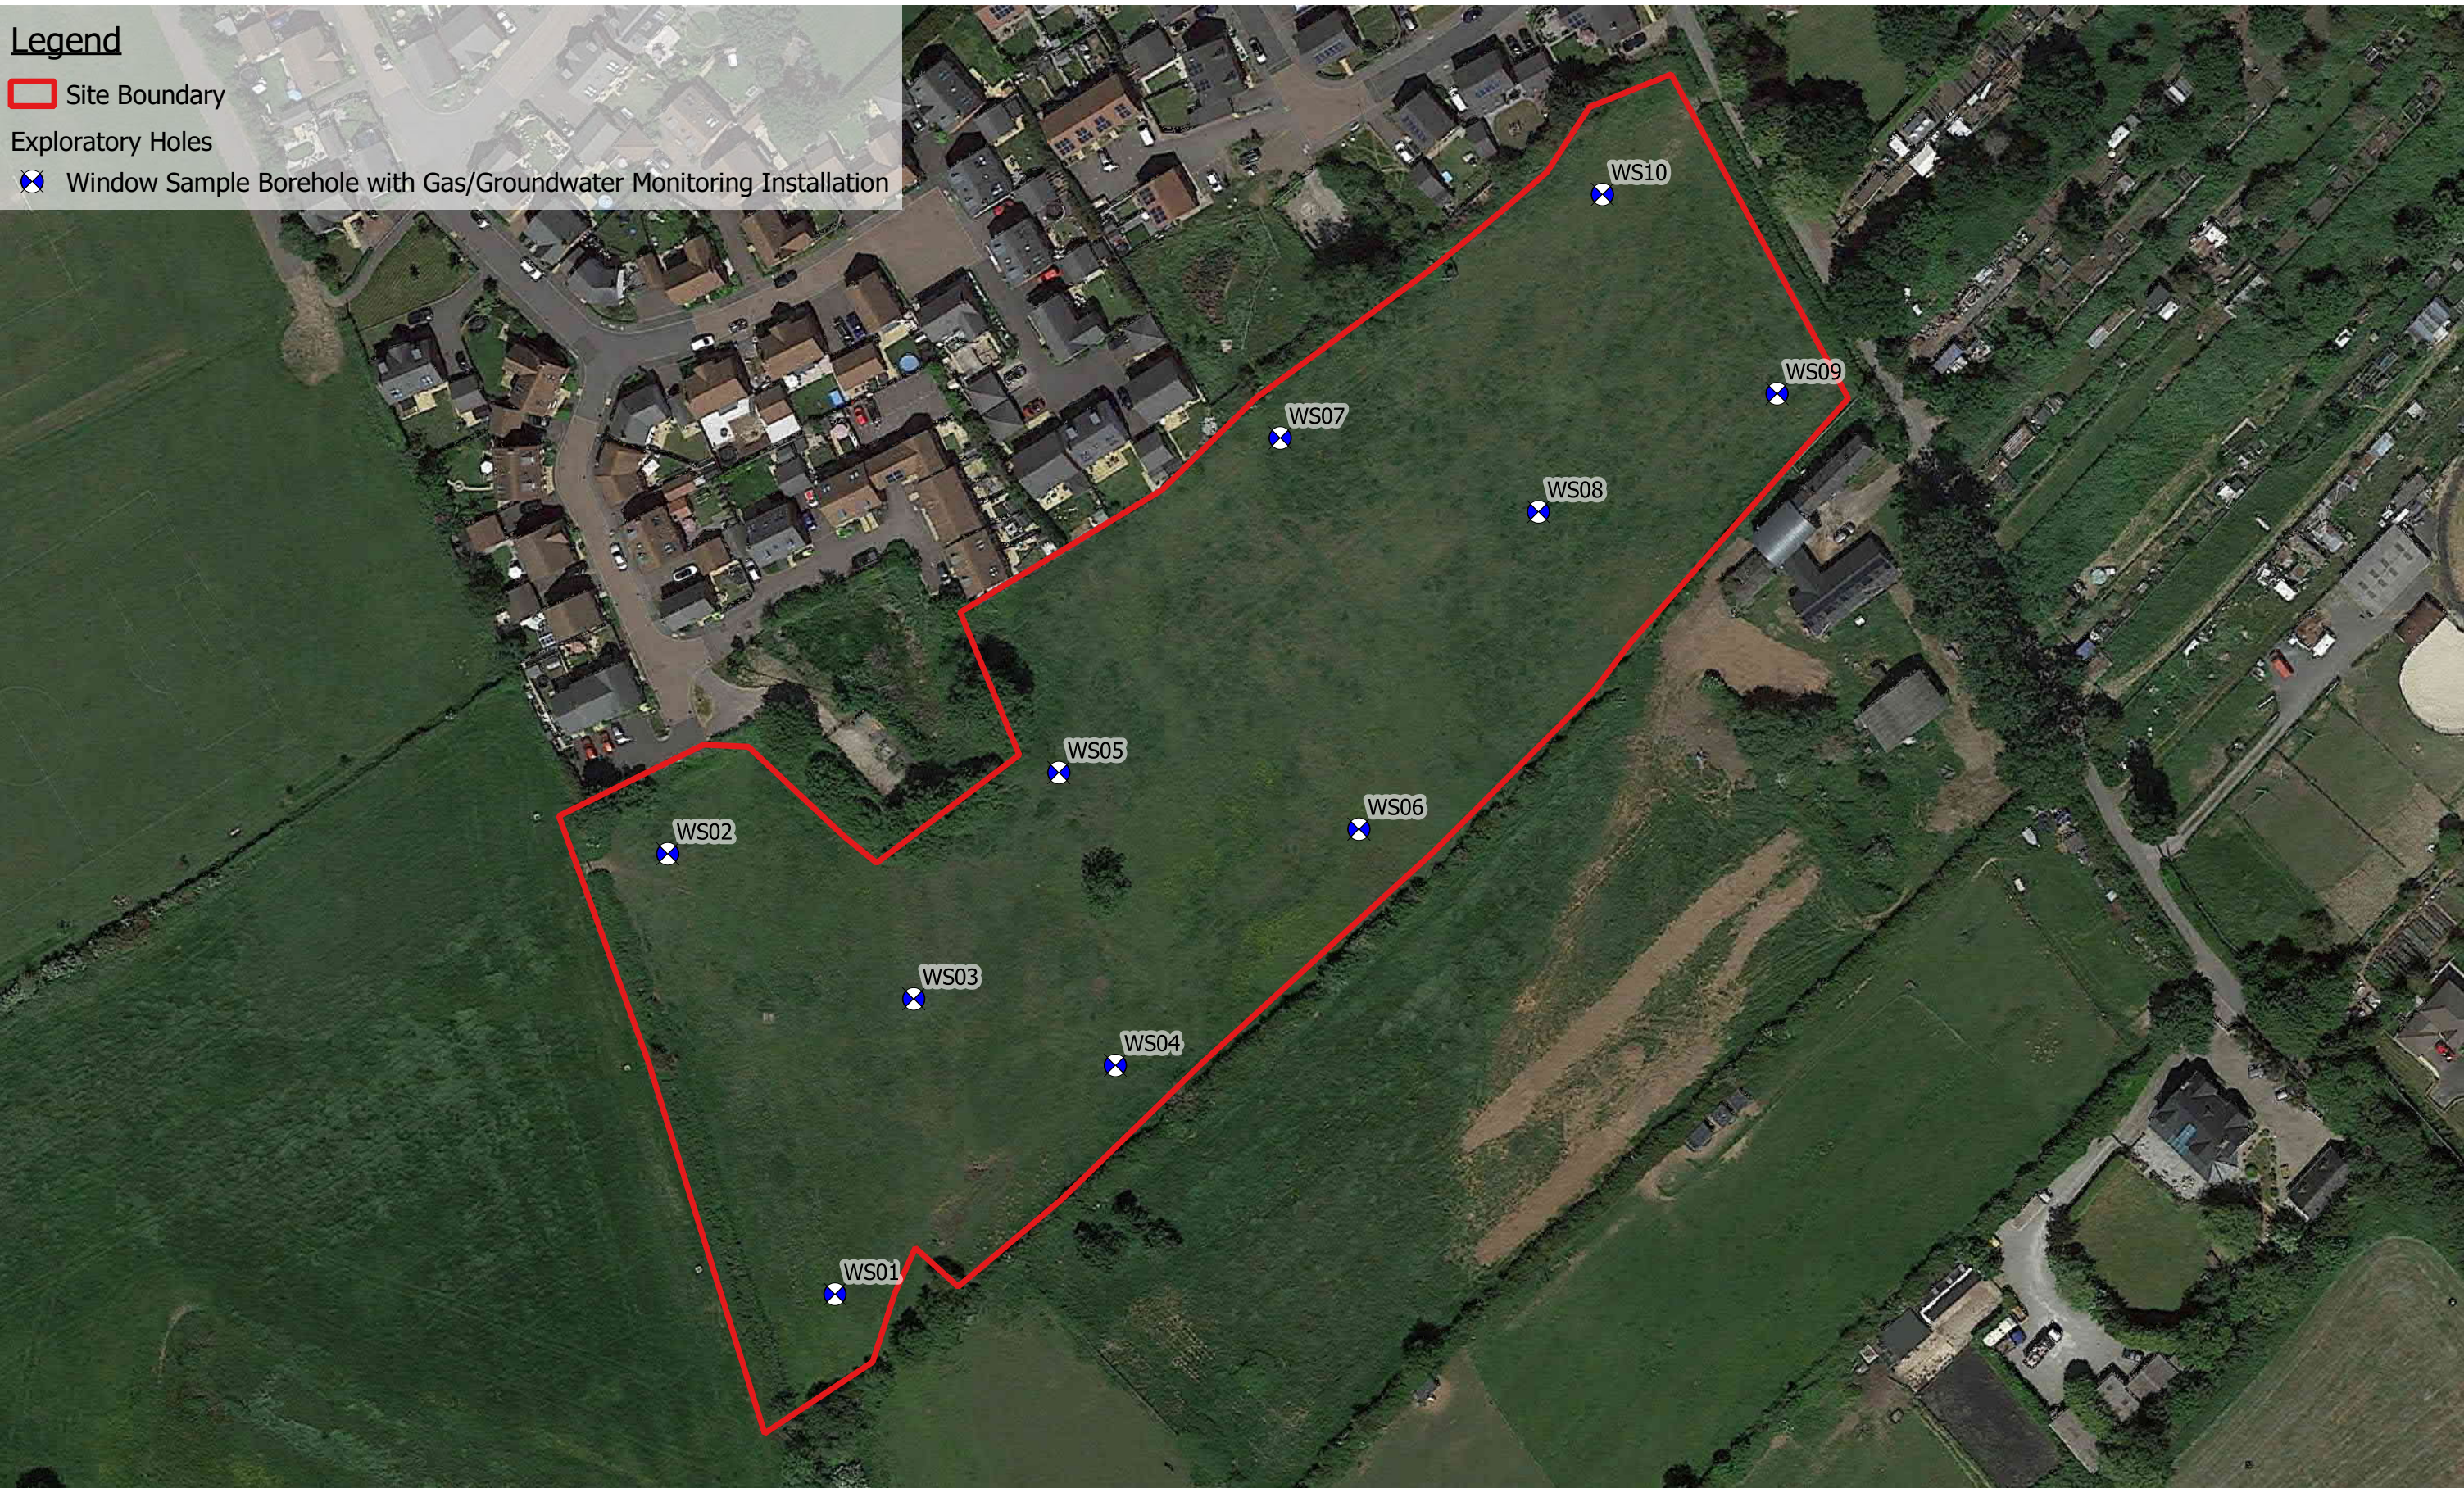
Window Sample Borehole with Gas/Groundwater Monitoring Installation

An Exploratory Hole Location Plan is presented in Appendix D.

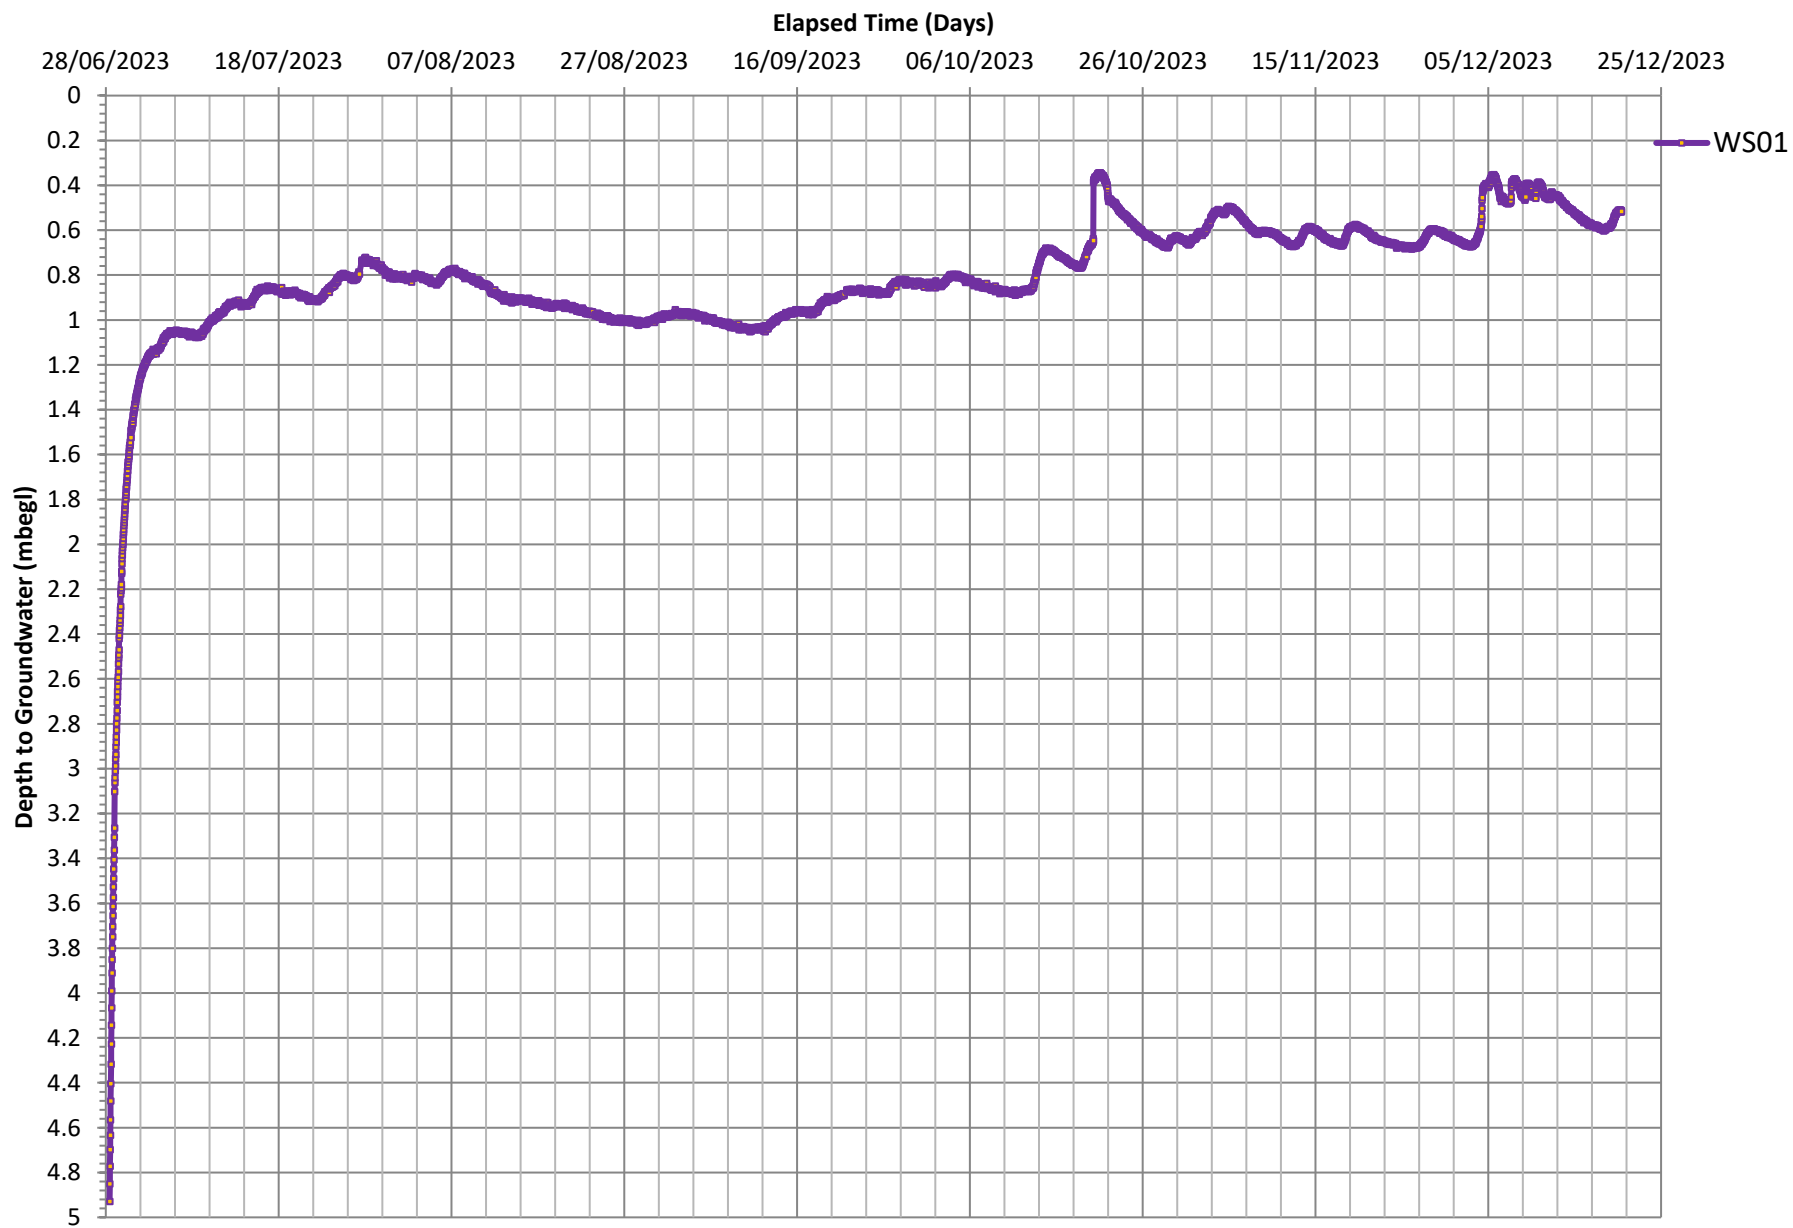
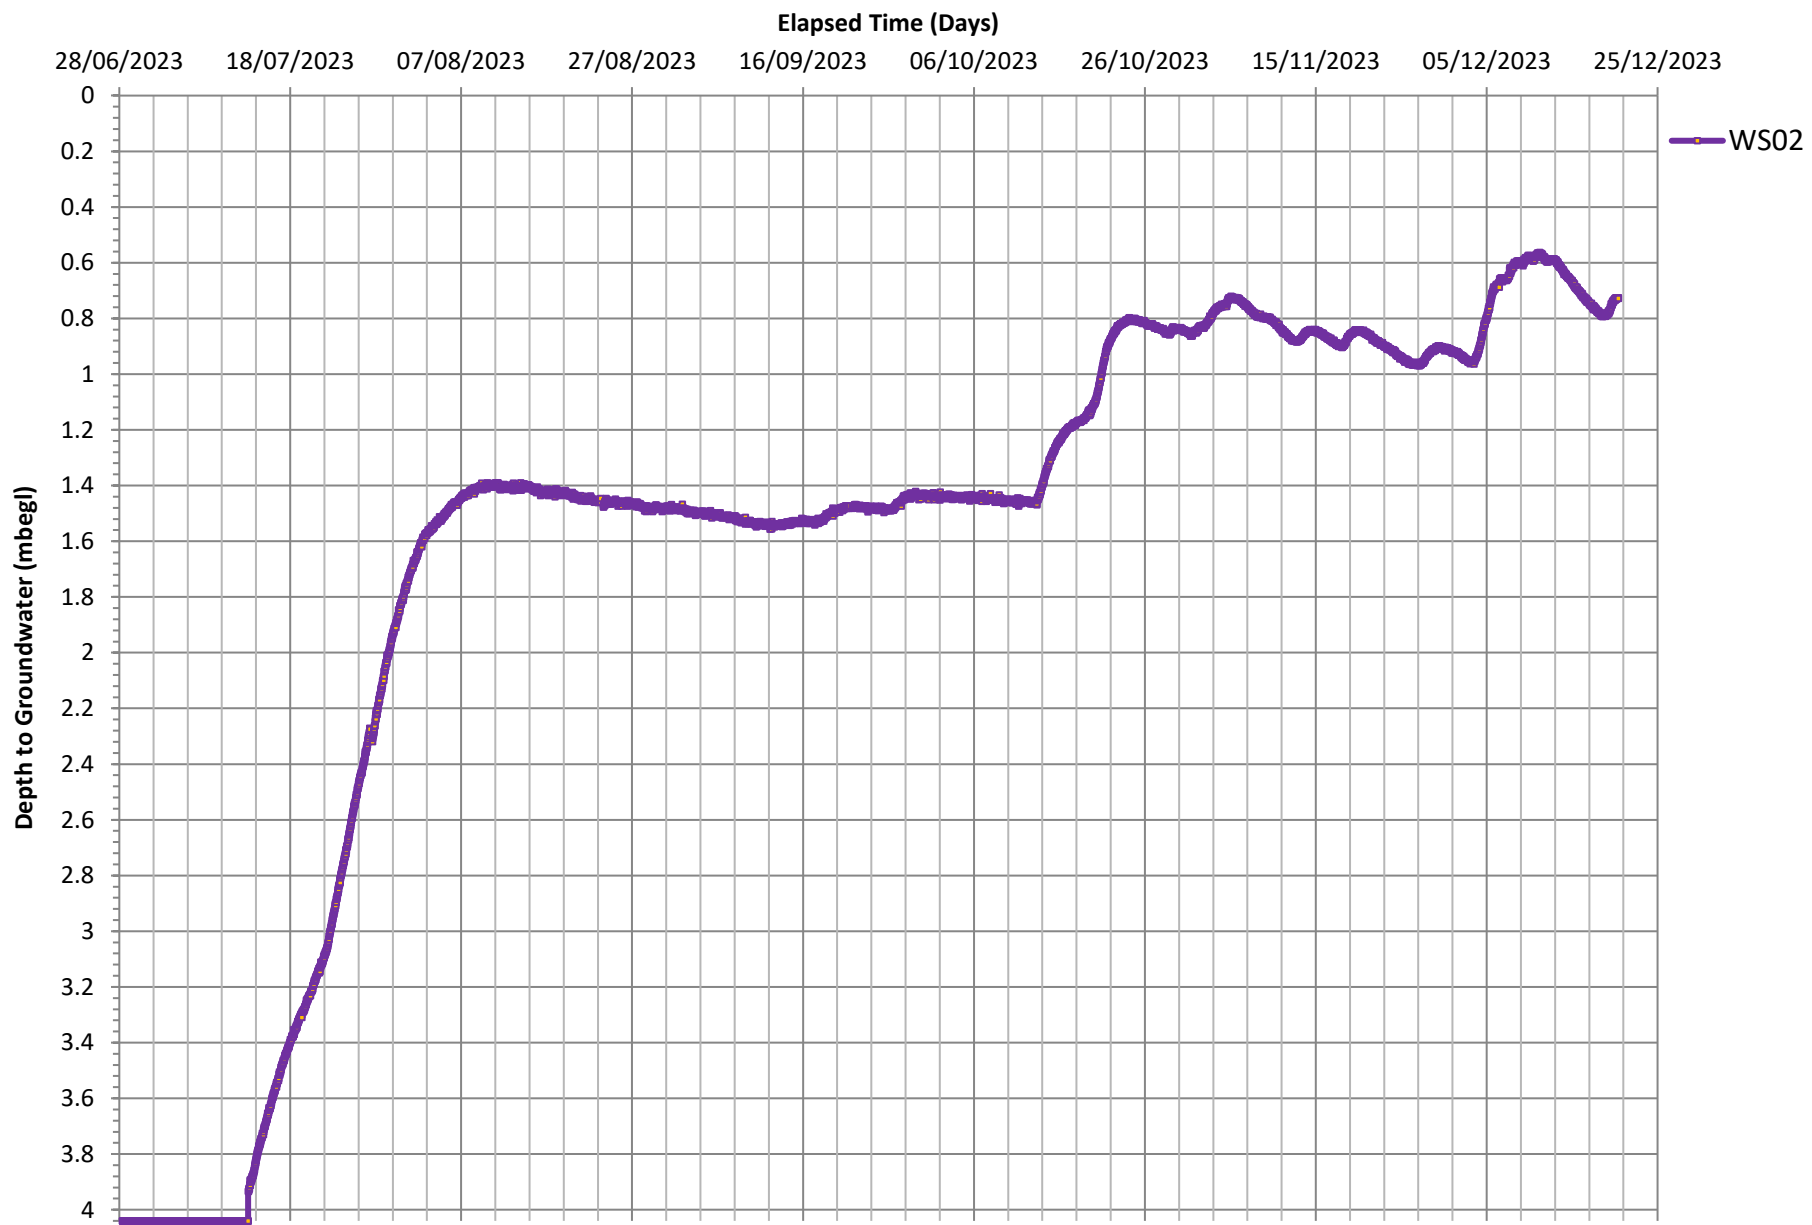
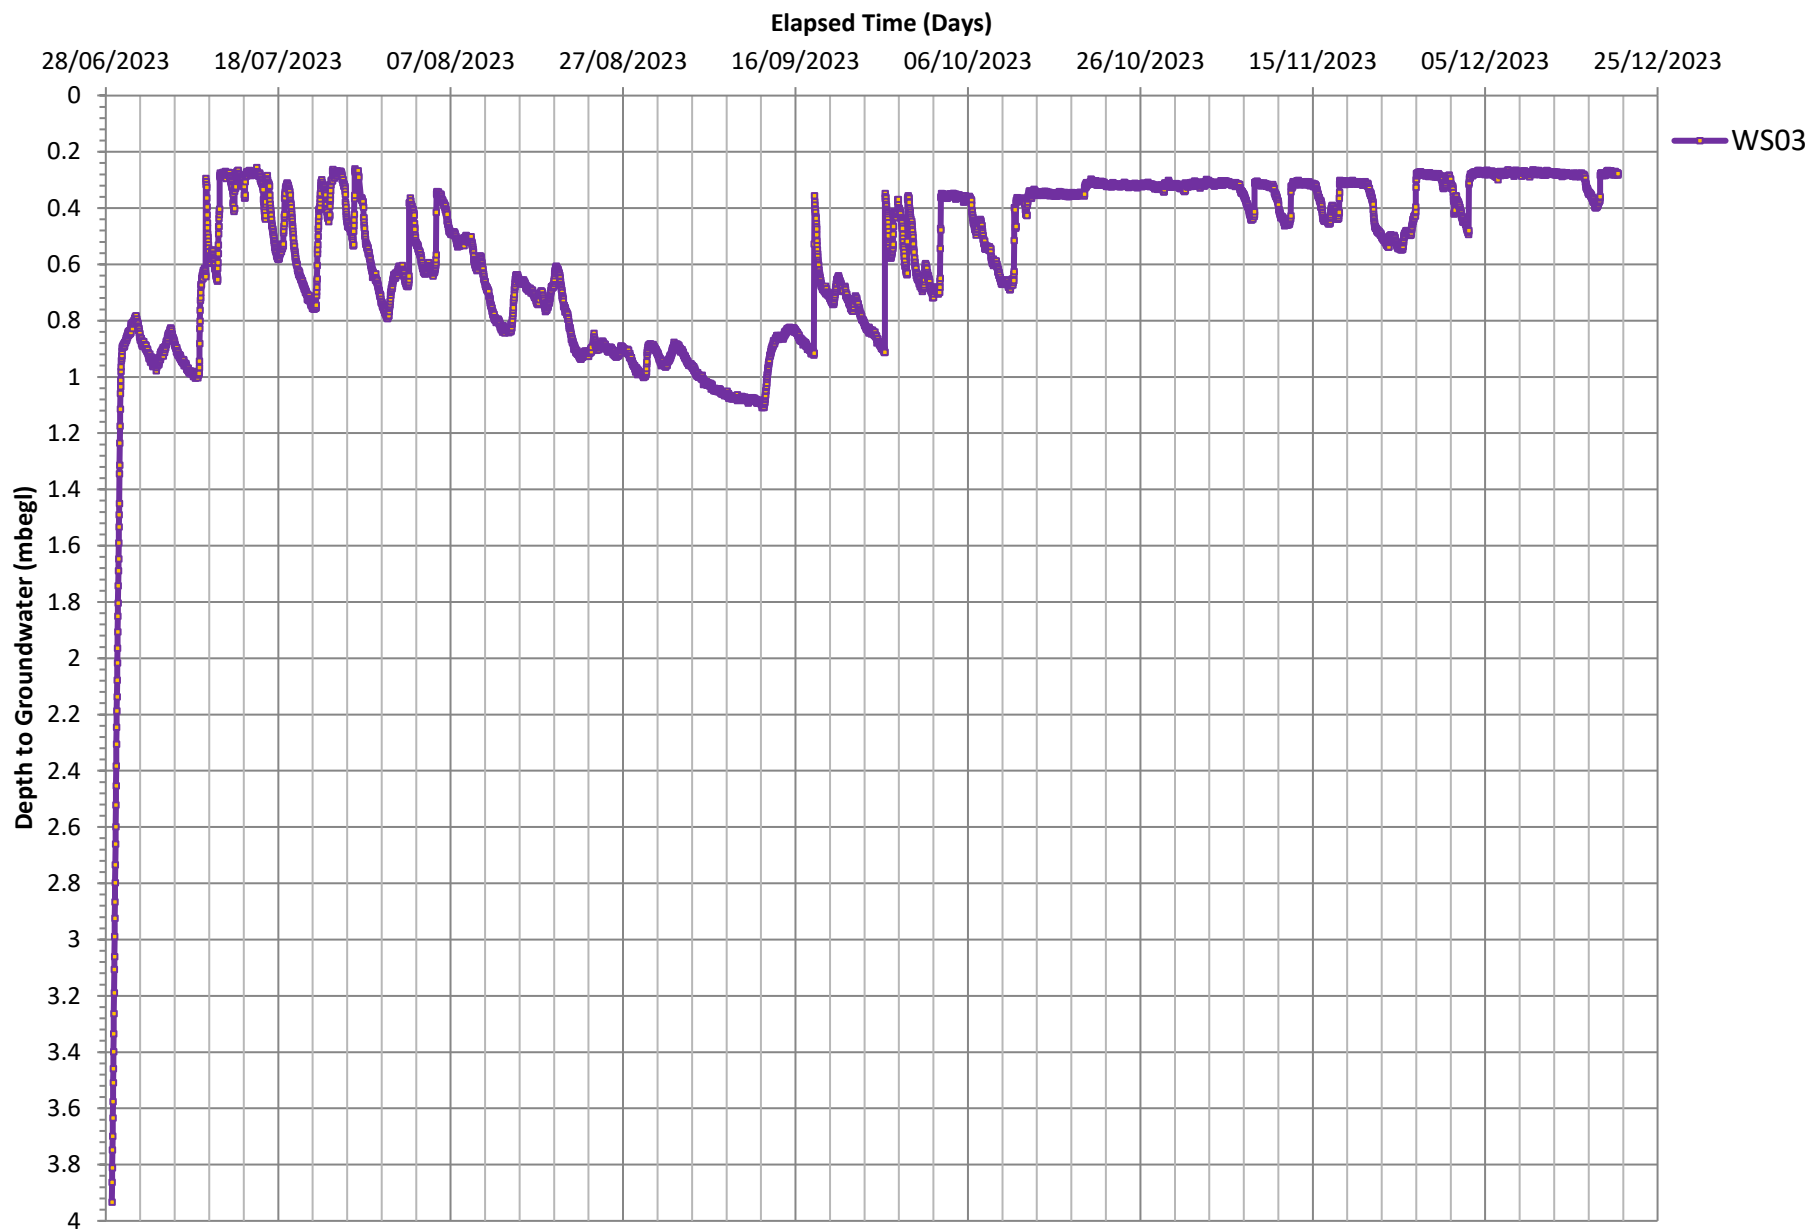
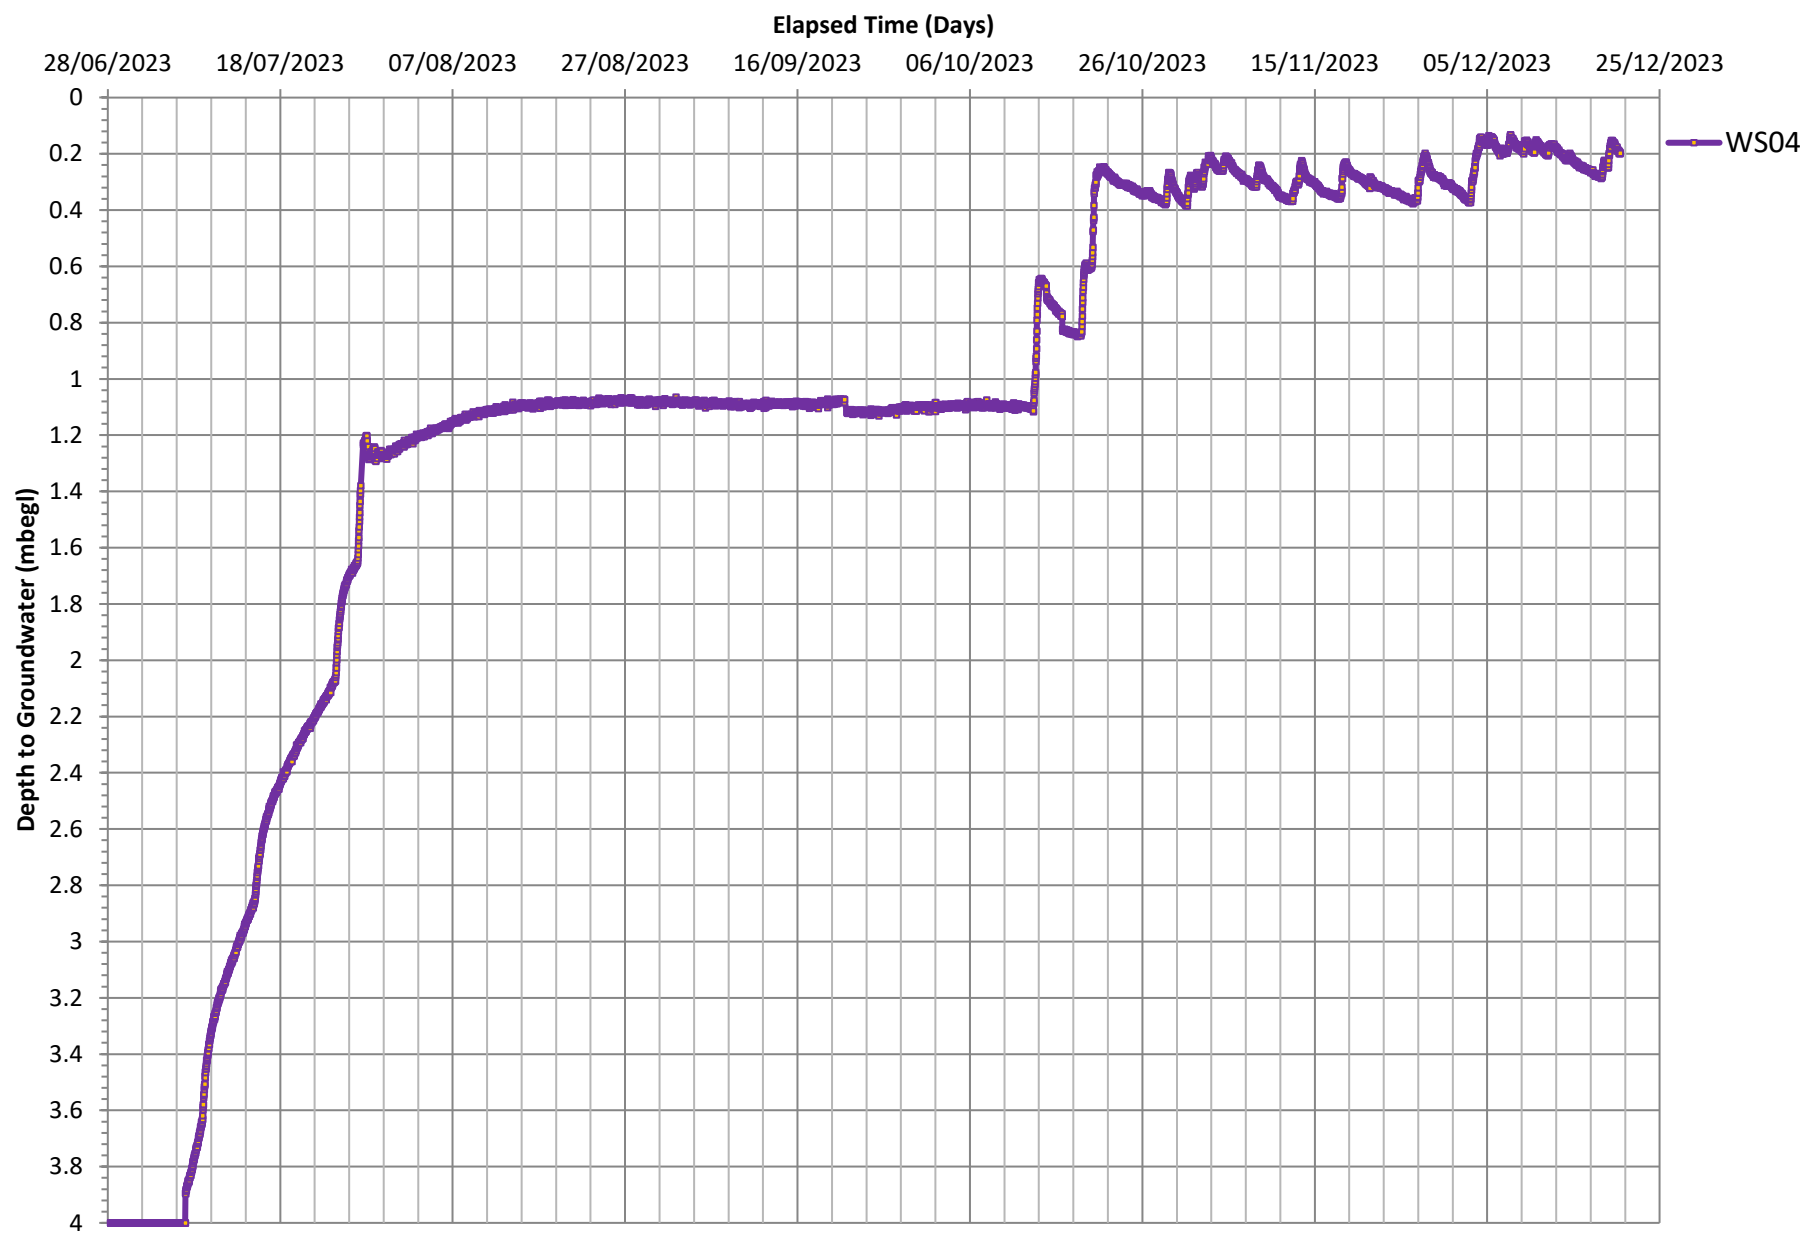
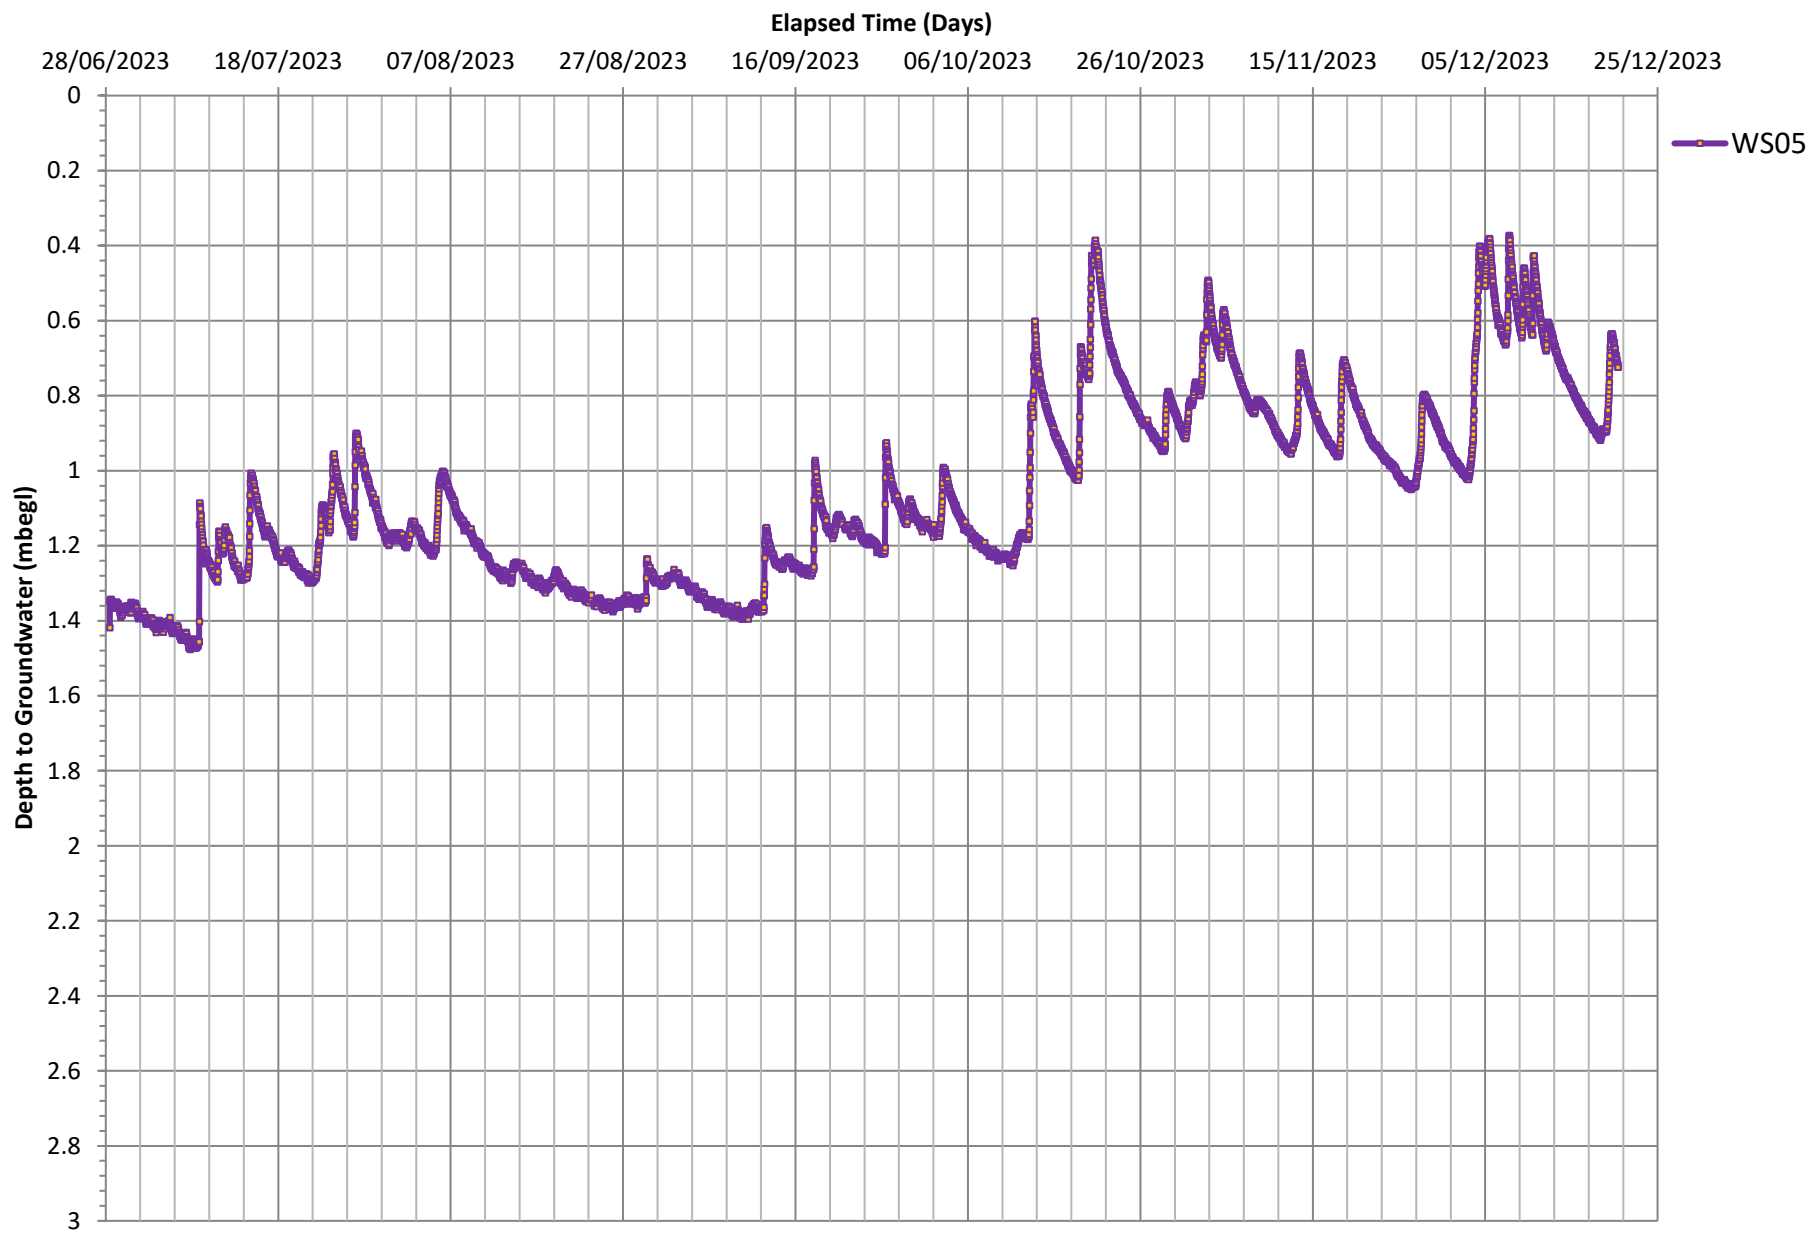
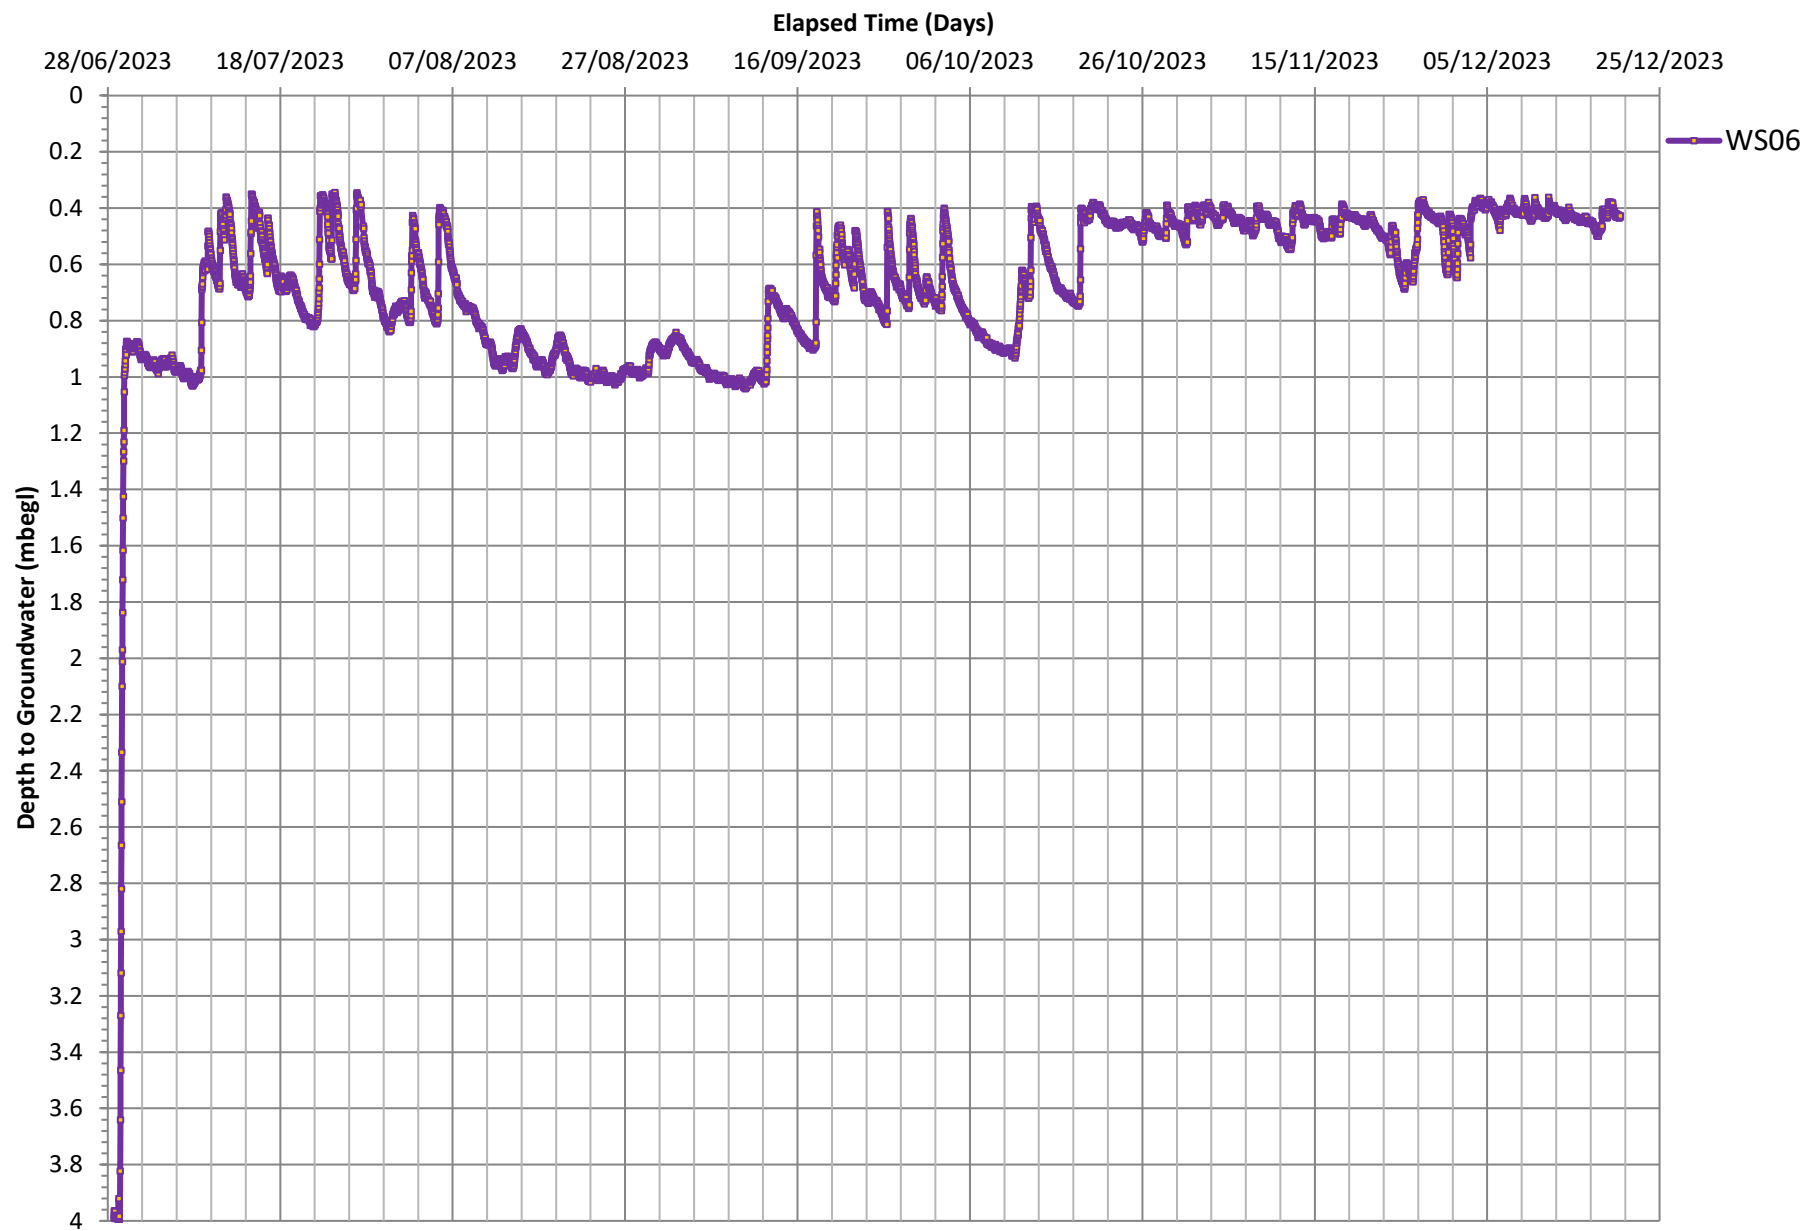
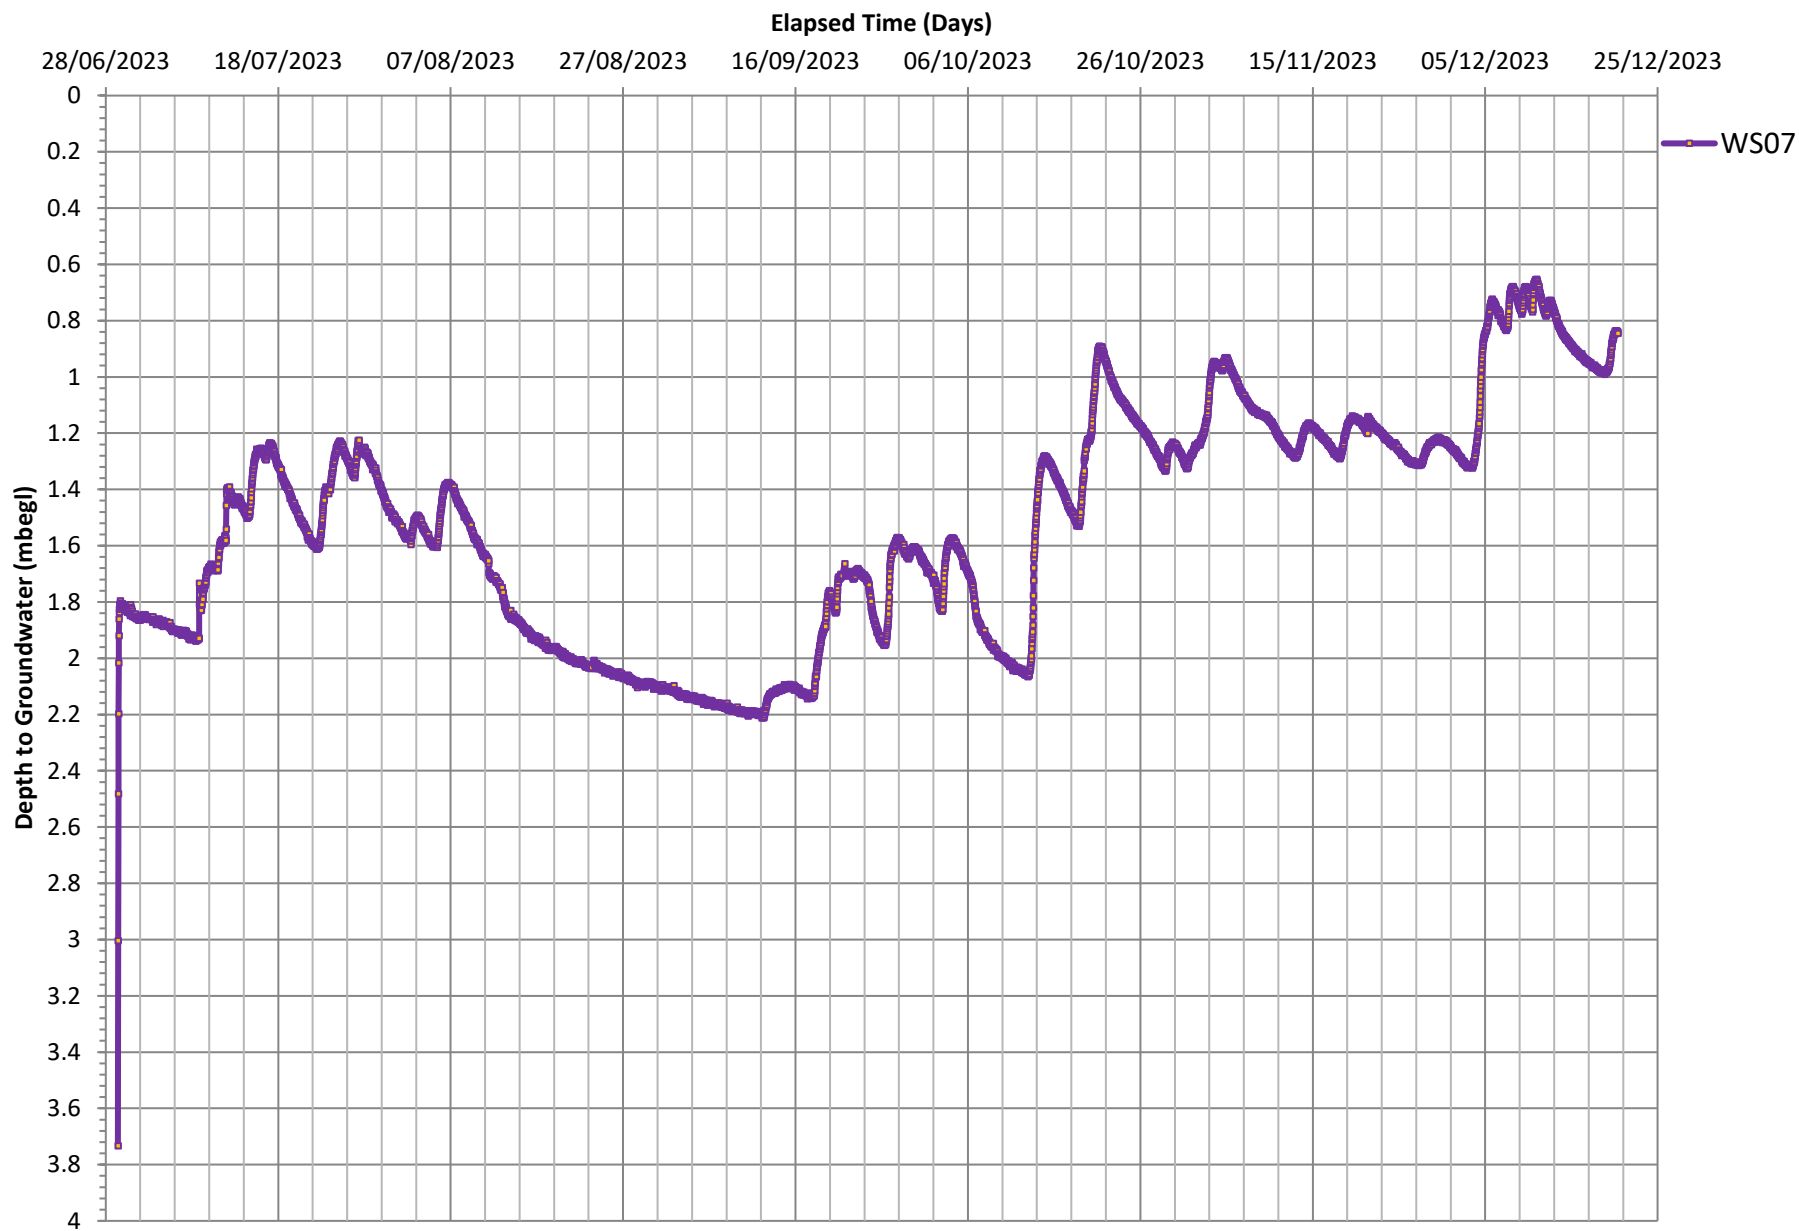
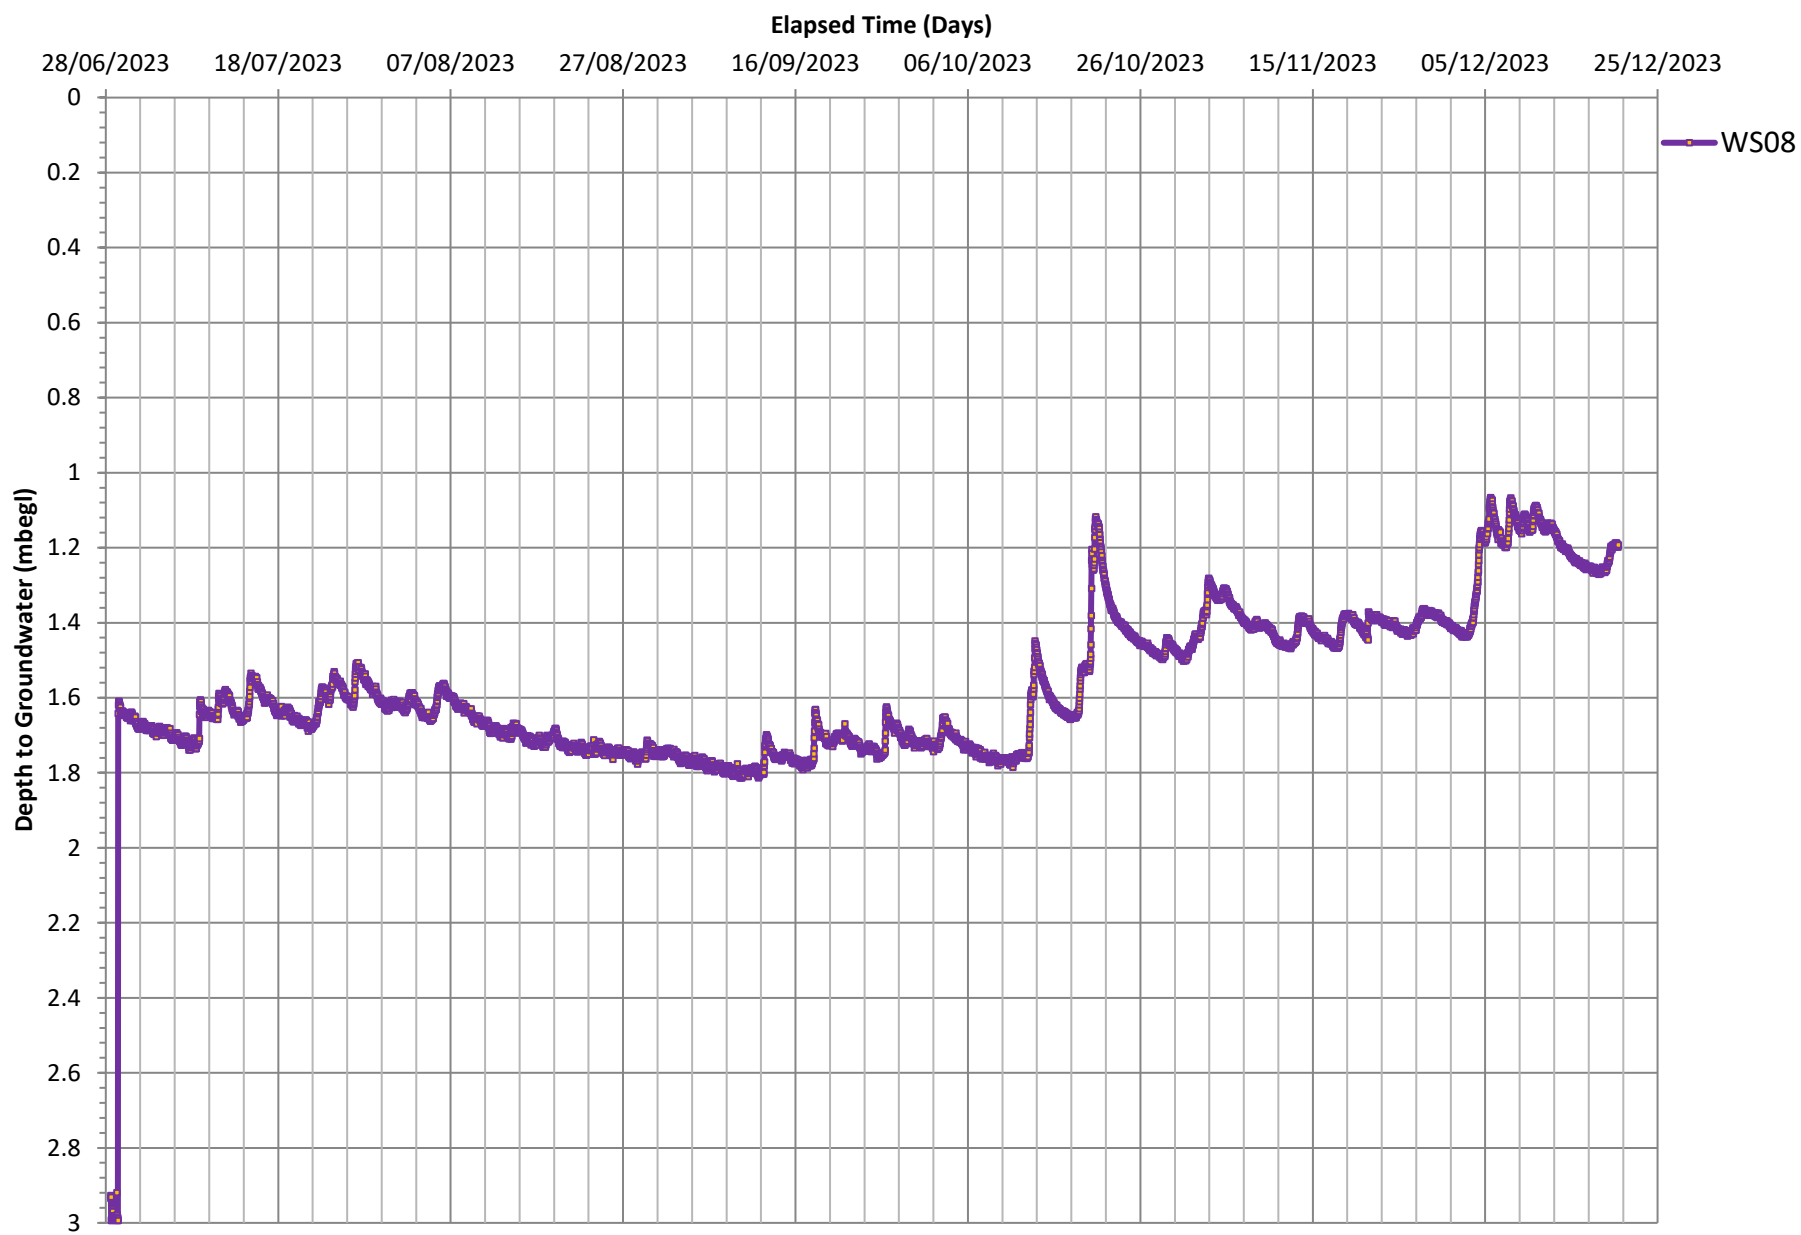
Groundwater monitoring has been conducted over a six month period between the 29<sup>th</sup> June and 20<sup>th</sup> December 2023, the results are presented in Appendix F and are summarised below:

The results suggest that the groundwater is generally shallow, with a general deepening in the east of the site (WS07-WS10) relative to surface levels, and at slightly shallower depths in the west (WS01-WS03) and centre (WS04-WS06). The shallow groundwater in the west of the site is considered to be representative of perched volumes within more granular horizons within the cohesive material of the Oadby Member, seeping into the monitoring wells and filling them over time. Due to the relatively impermeable nature of these deposits, the water is considered to have remained in the monitoring wells, therefore resulting in the impression of shallow groundwater in the western area, although this is not considered representative of the regional groundwater table. Similarly, the shallow groundwater in the east is considered to represent perched volumes; however, generally slightly deeper due to the topography and in part, the depths at which granular horizons are present. The groundwater monitoring results suggest there are more significant volumes of groundwater in the centre of the site with the shallowest readings being recorded in this area, corresponding to the presence of more granular deposits of Alluvium and Wolston Sand and Gravel.

It is considered that overall, the data indicates a flow direction to the south west, in line with the local topography, with local shallowing, particularly in the area of granular deposits and close to the spring recorded on historical mapping. A plan illustrating the shallowest groundwater levels monitored across the site is presented in Appendix G.
