Our Ref: P9013/LET-1

**RE: Groundwater Monitoring Completion Letter Report for Land off Workhouse Lane, Burbage**

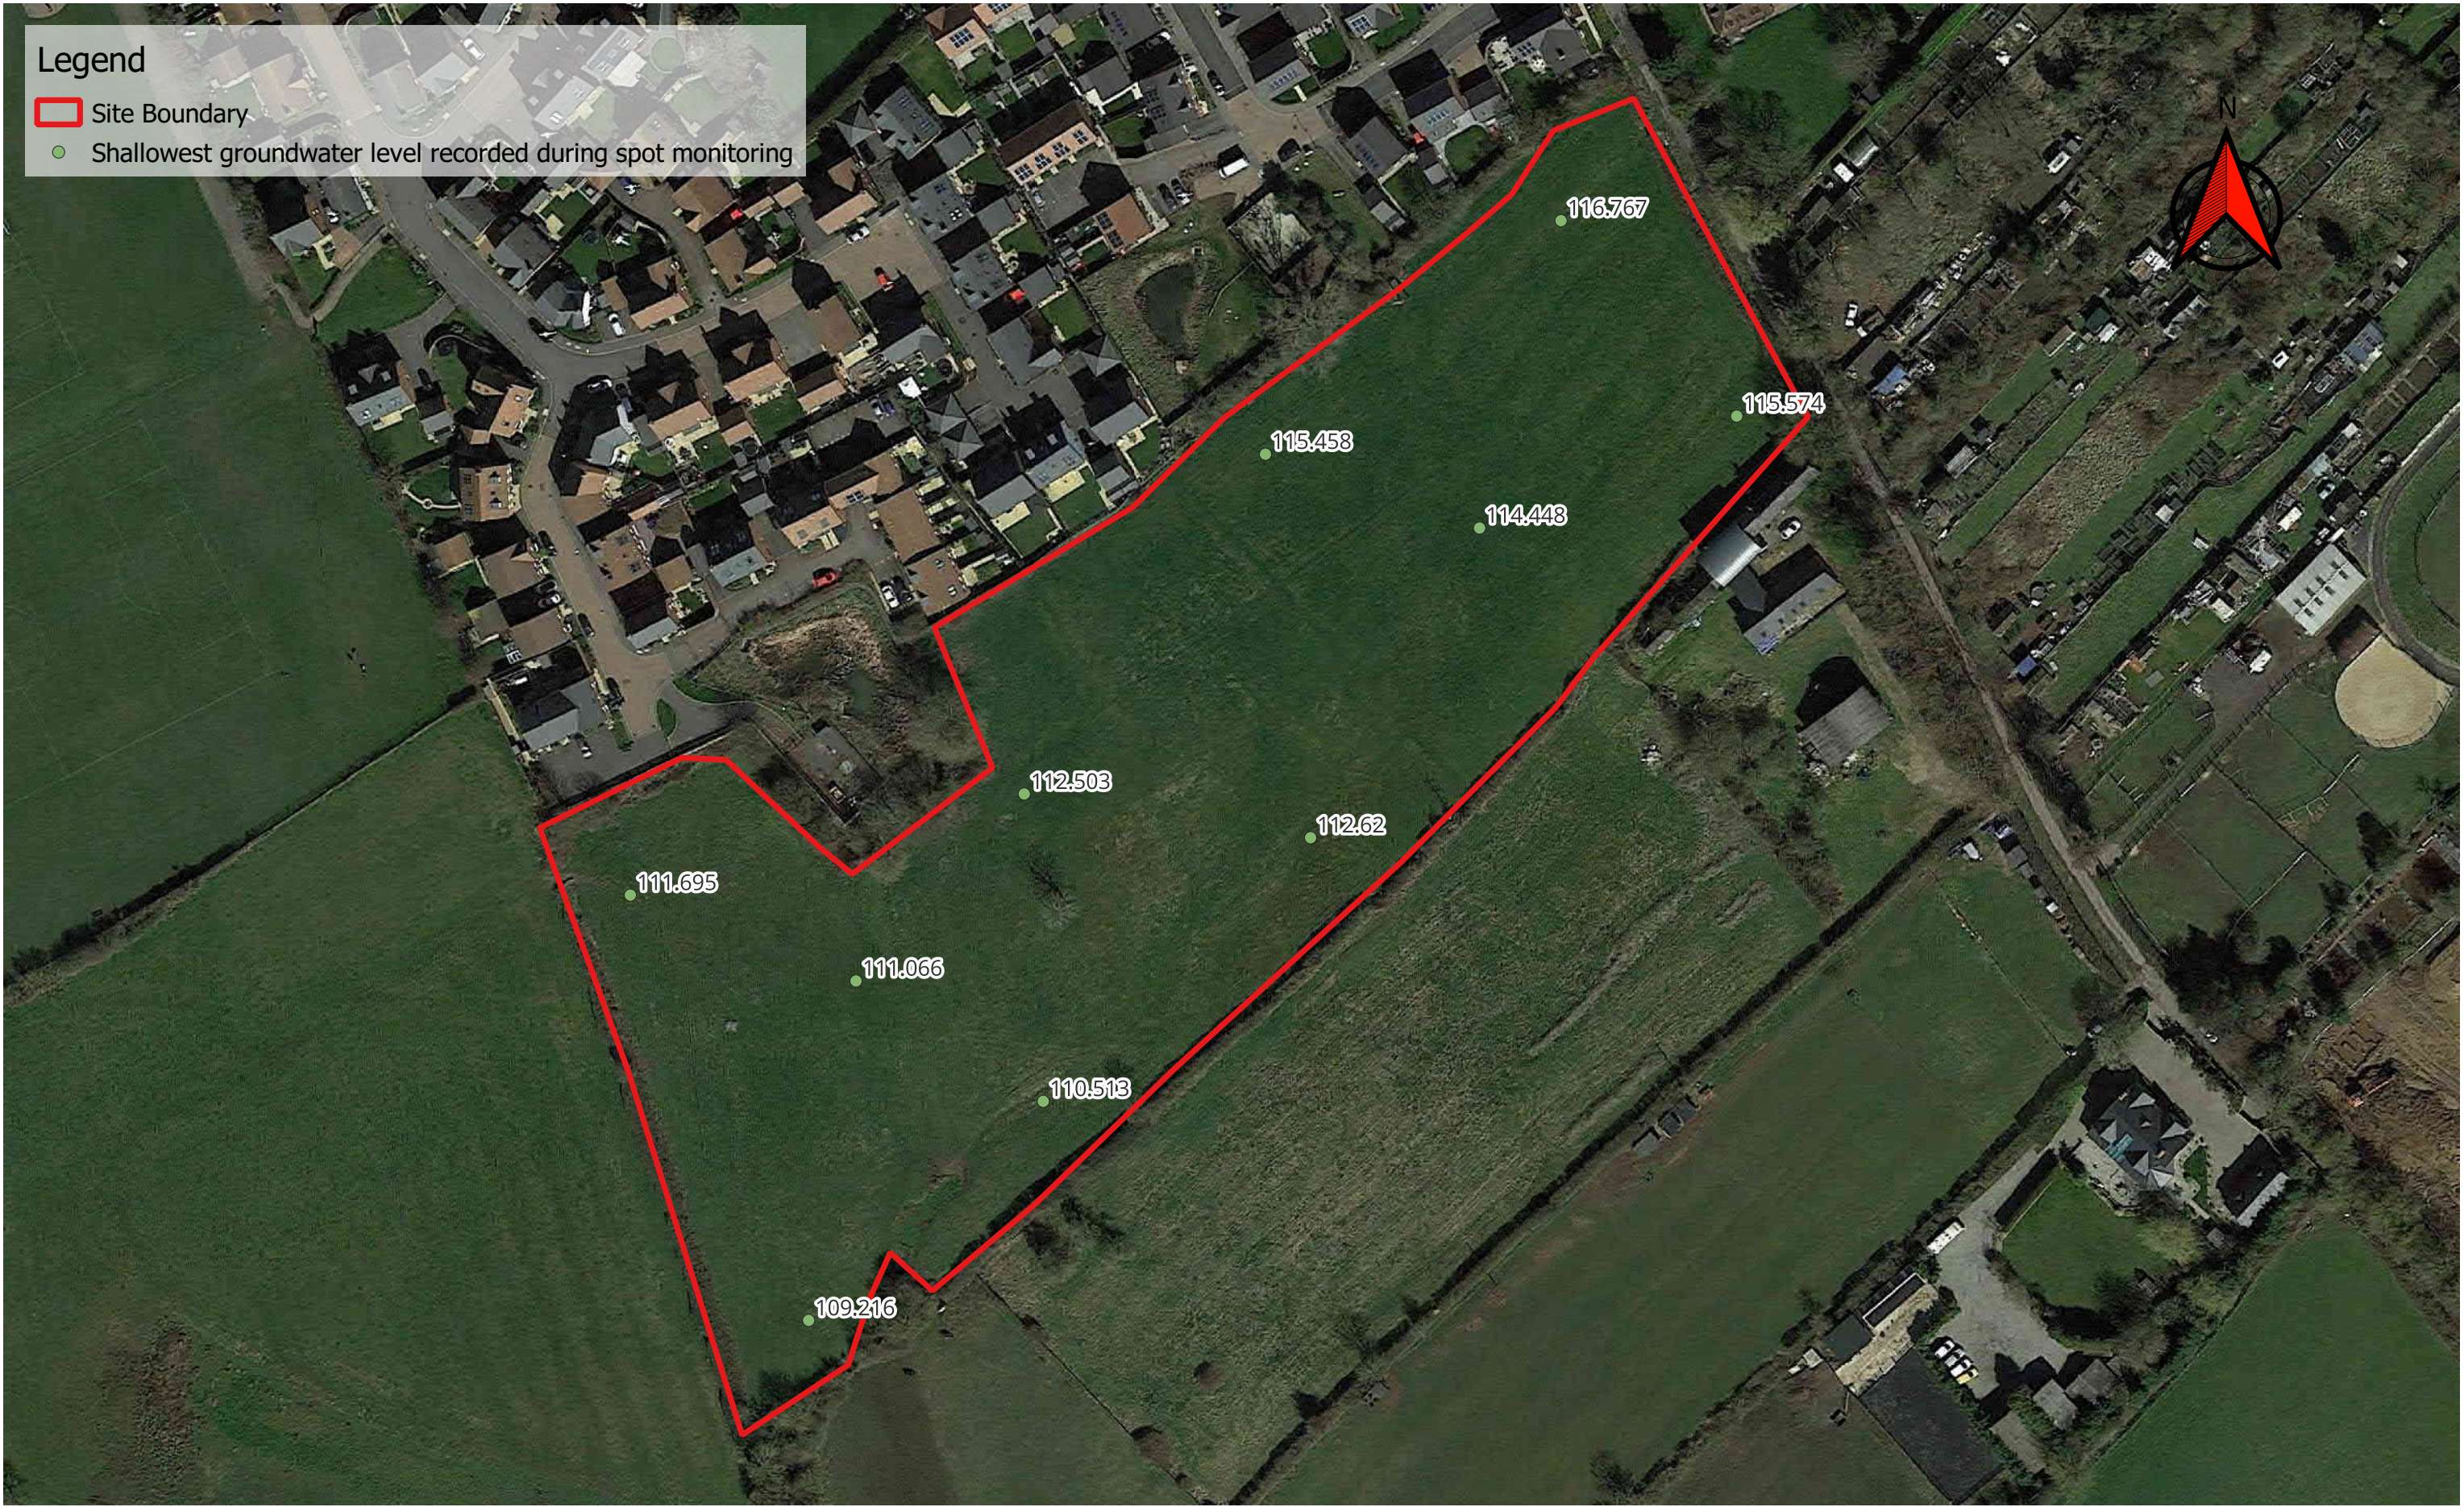
- Site Boundary
- Shallowest groundwater level recorded during spot monitoring

It is considered that overall, the data indicates a flow direction to the south west, in line with the local topography, with local shallowing, particularly in the area of granular deposits and close to the spring recorded on historical mapping. A plan illustrating the shallowest groundwater levels monitored across the site is presented in Appendix G.

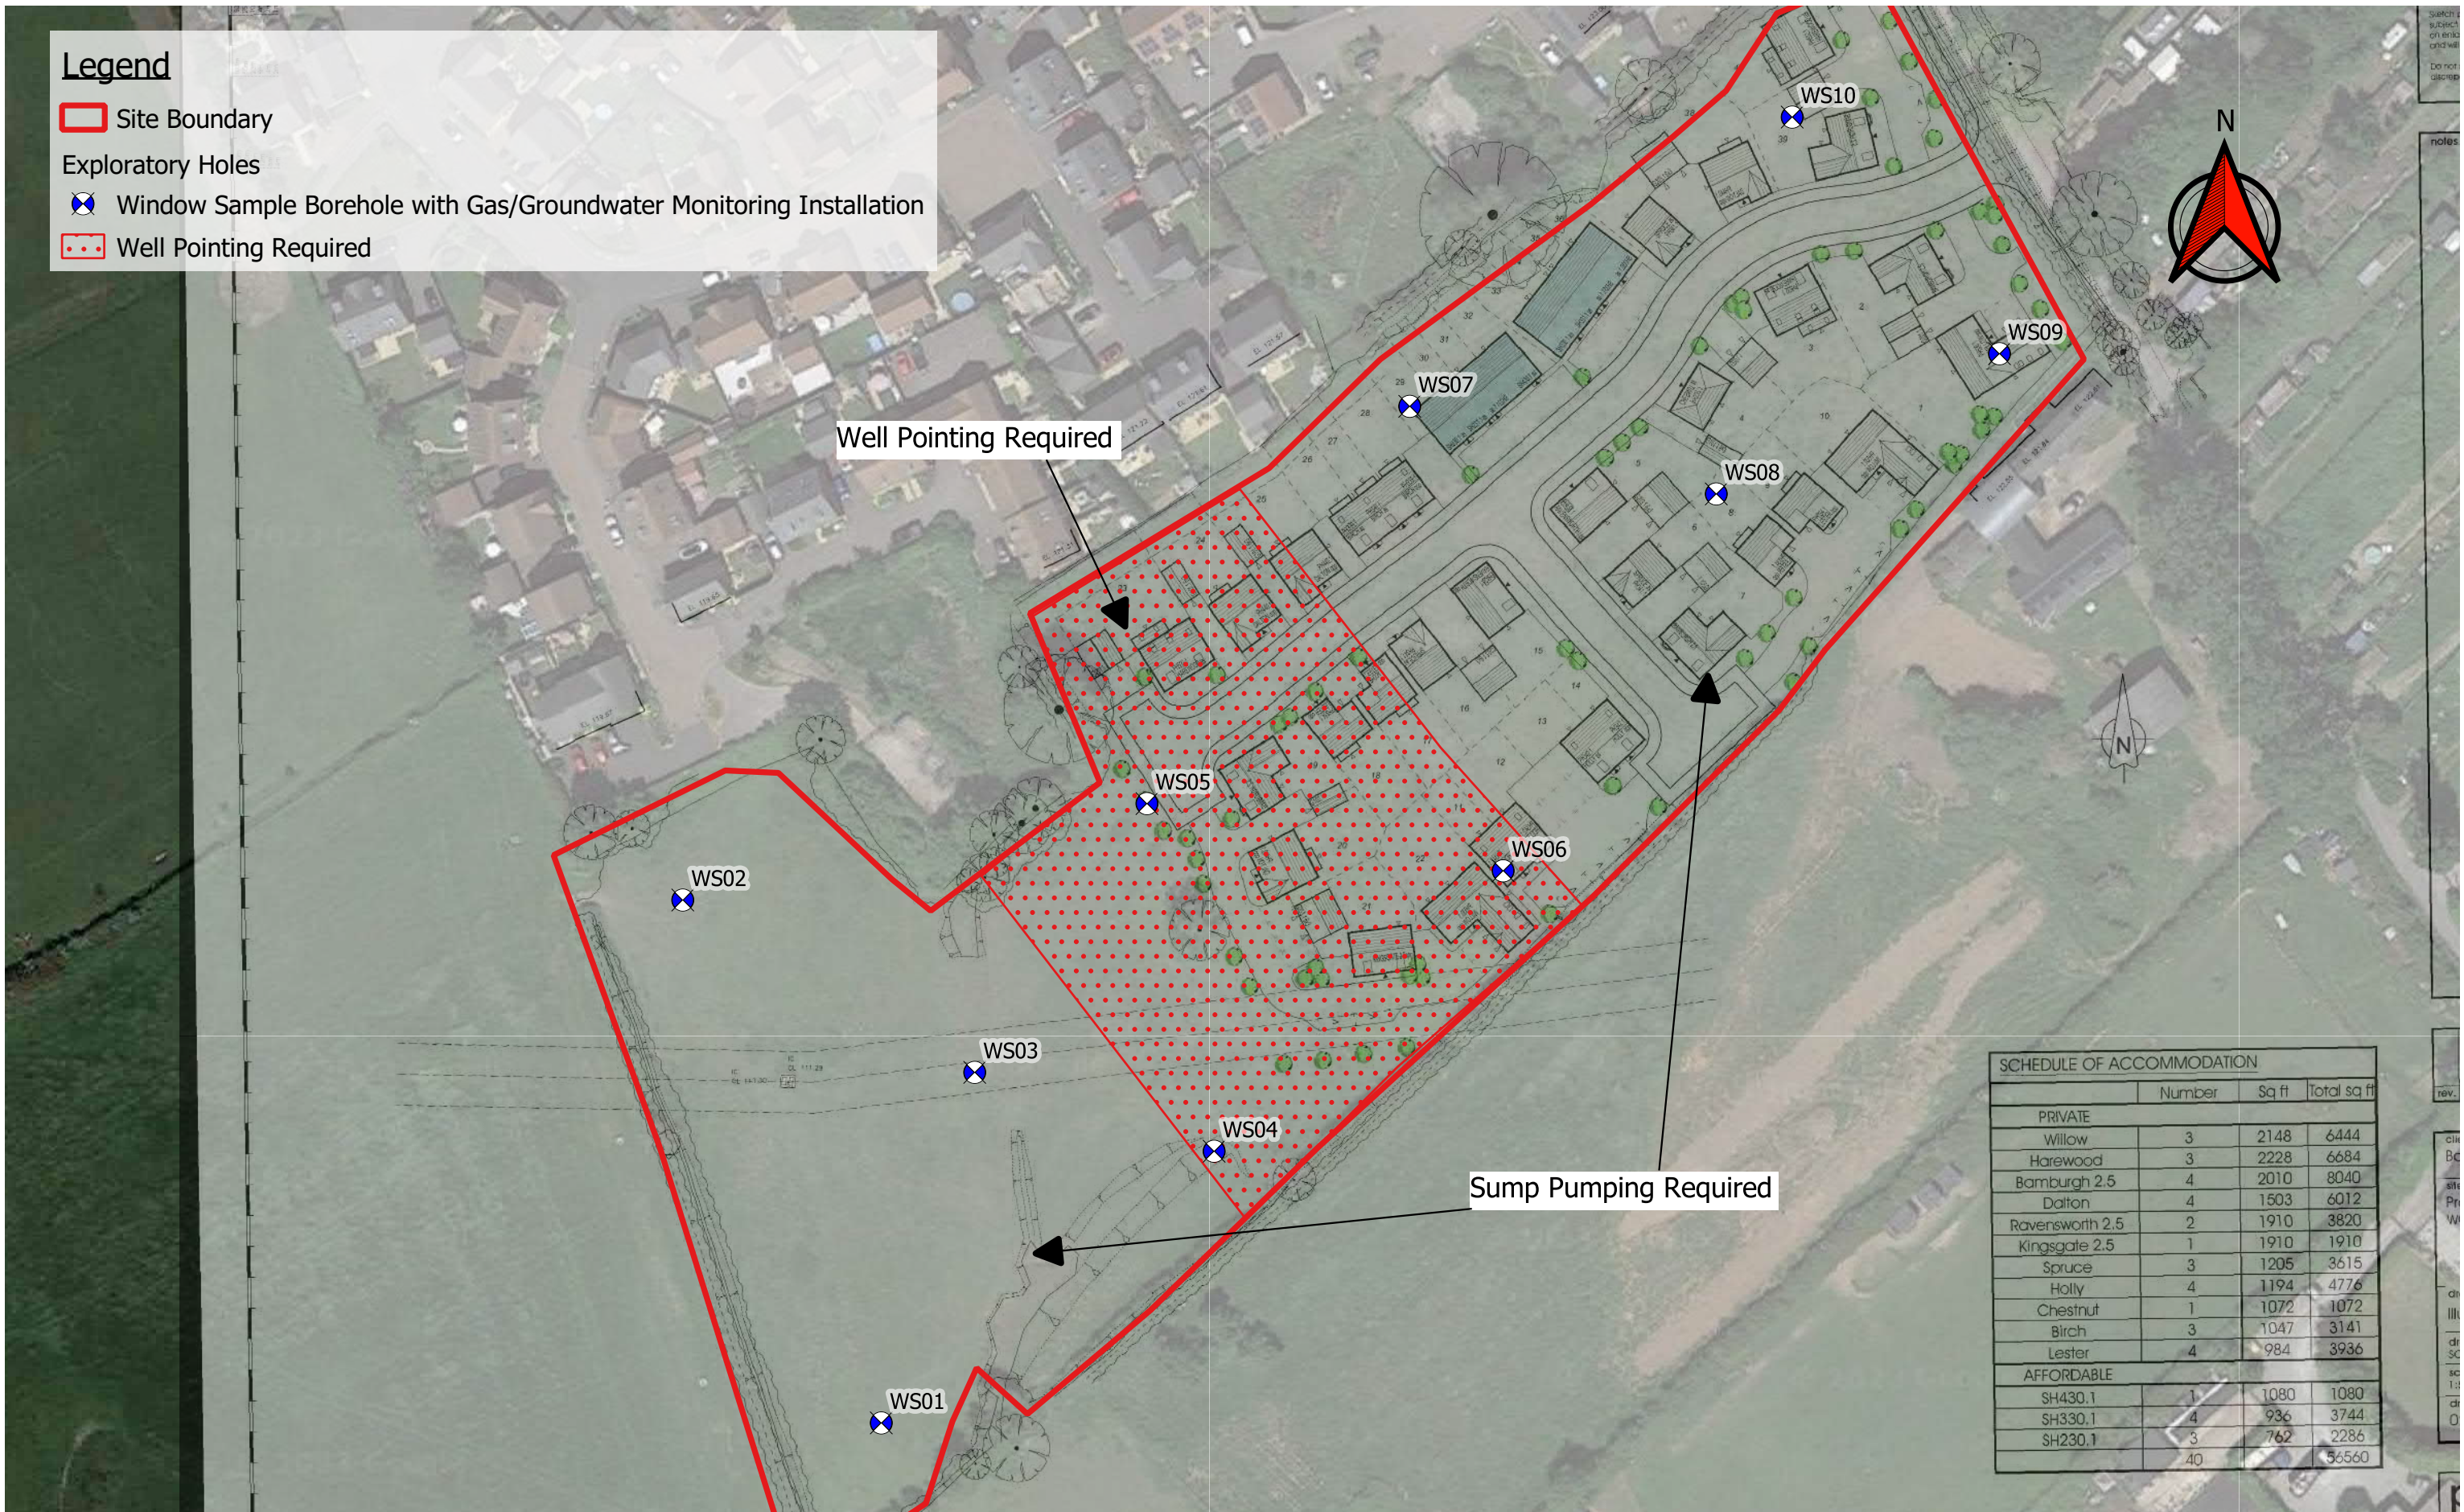
DEWATERING RECOMMENDATIONS PLAN

Well Pointing Required

The groundwater monitoring period confirmed the presence of groundwater in the east of the site, although the results suggest that the groundwater is deeper in this area compared to the rest of the site, with localised areas of shallower groundwater. Therefore, as the groundwater depths are variable in this area, rather than indicating a pervasive and continuous water table, an allowance should be made for localised simple dewatering techniques such as sump pumping. However, it is considered prudent to make allowance for more aggressive dewatering for any medium to long term excavations deeper than 1m.

The groundwater monitoring period confirmed the presence of groundwater in the west of the site, although this is considered to be representative of perched volumes within more granular horizons within the predominantly cohesive material in this area, suggesting only minor volumes are present. As the current development layout does not propose any plots in the western area, no dewatering is required, although if the development layout were to be revised, it would be considered prudent to allow for simple dewatering techniques such as sump pumping in the west of the site, with consideration given to well pointing for medium to long term excavations deeper than 1m.

The groundwater monitoring period confirmed the presence of significant volumes of groundwater within the granular strata in the centre of the site. As such, it is considered that simple dewatering techniques are not suitable for this area, and more aggressive dewatering techniques such as well pointing are recommended.

A plan showing the dewatering recommendations is presented in Appendix H.
