LAND OFF WORKHOUSE LANE, BURBAGE,
HINCKLEY

PHASE II SITE APPRAISAL REPORT
FOR
MATHER JAMIE

Project Ref:
P9013

Date:
August 2023

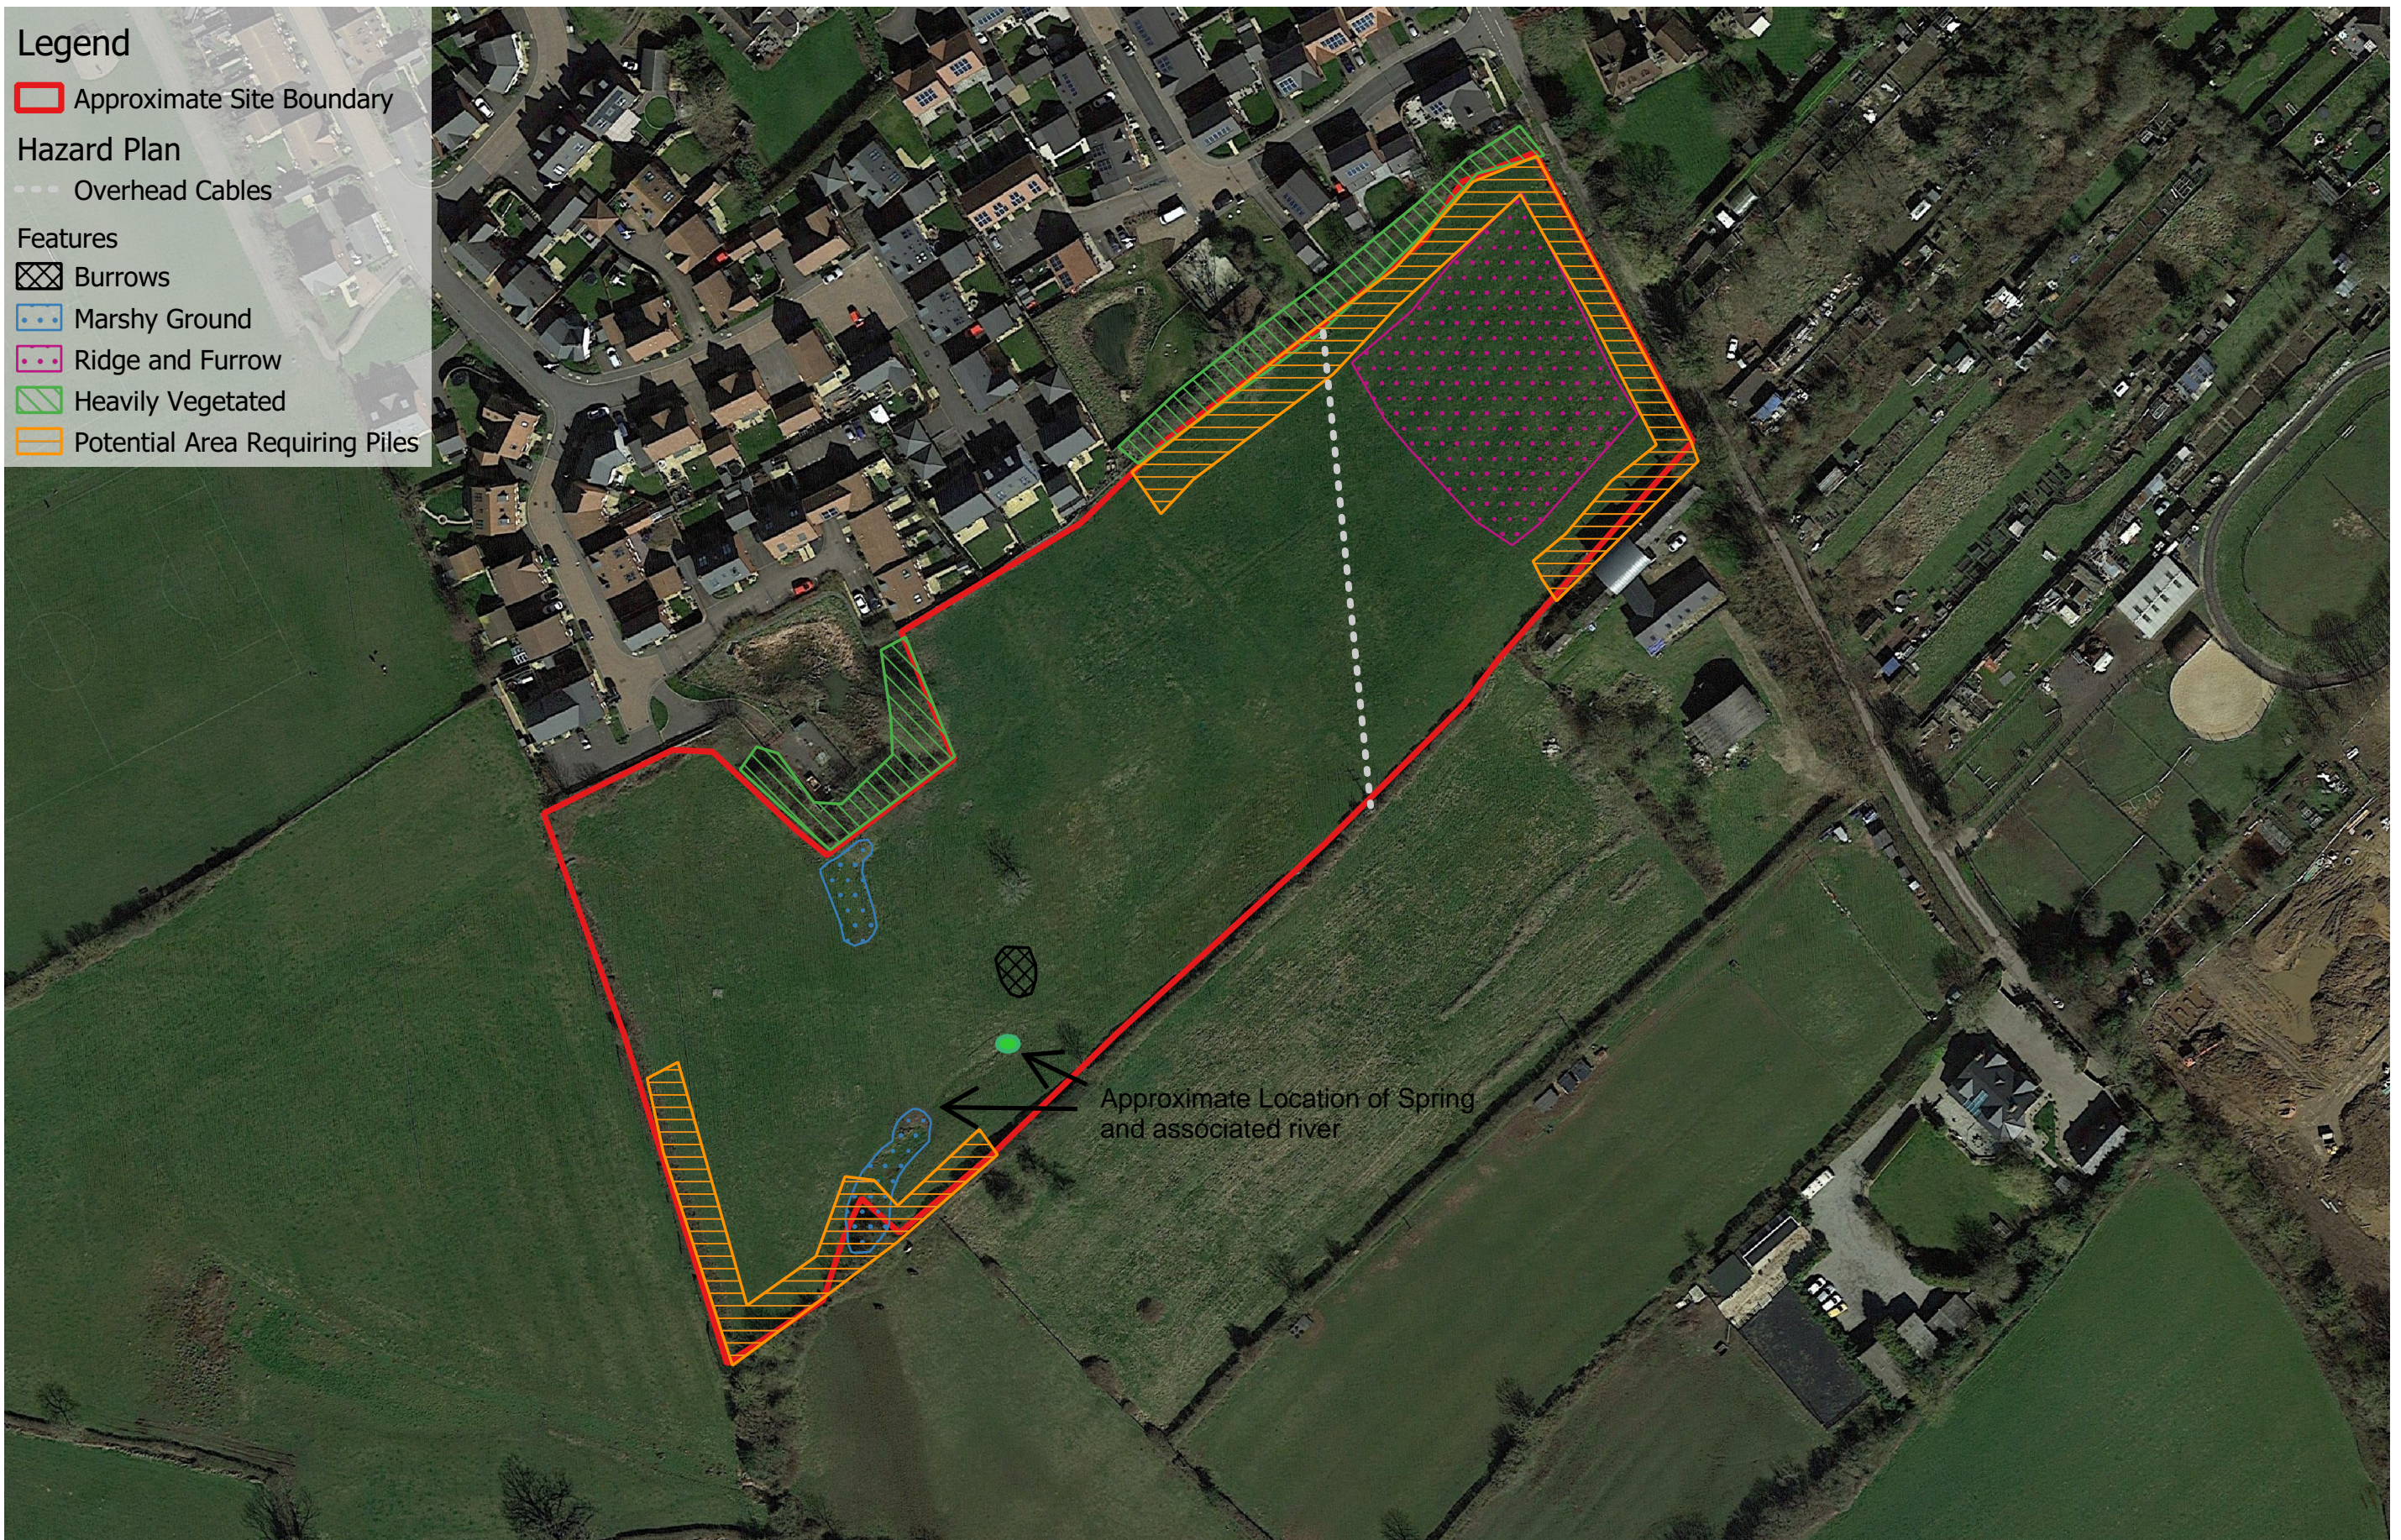
|||| Heavily Vegetated

|||| Potential Area Requiring Piles

Additionally, due to the influence of trees, it is possible that an additional 10% of the site could have foundations bearing at depths in excess of 2.5m begl (i.e within the engineer design zone); these areas are highlighted on the Foundation Zone Plan presented in Appendix K. Desiccation testing (to be undertaken in the summer months if trees are to remain or can be conducted at any time once removed) could be undertaken to determine a safe bearing depth for traditional foundations. However, until this is undertaken and given the variability of the soils, it would be prudent to allow for piling all plots within the engineer design zone.

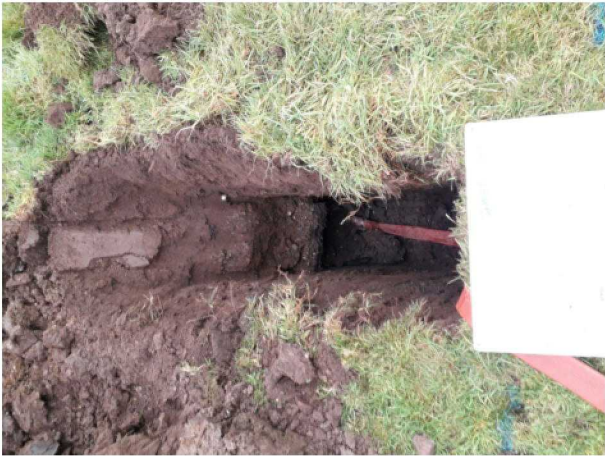
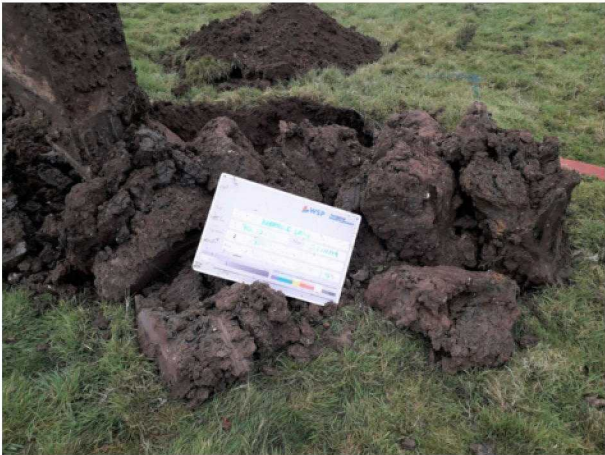
1.70	B								(0.50) 110.16 0.50 109.96 0.70 (1.10) 108.86 1.80	Dark brown slightly clayey slightly gravelly fine to coarse SAND with frequent rootlets. Gravel is fine to coarse subangular to rounded of chert. (TOPSOIL)

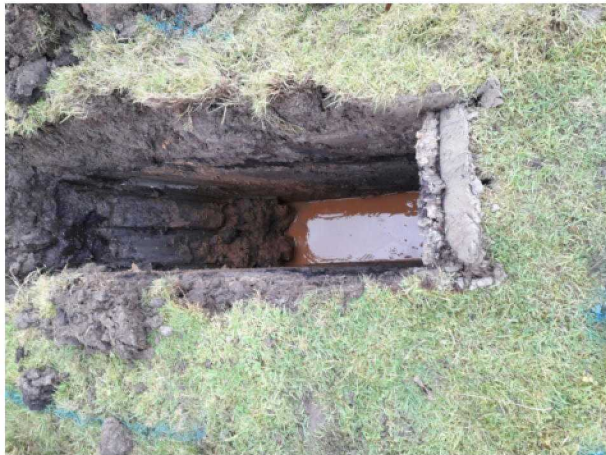
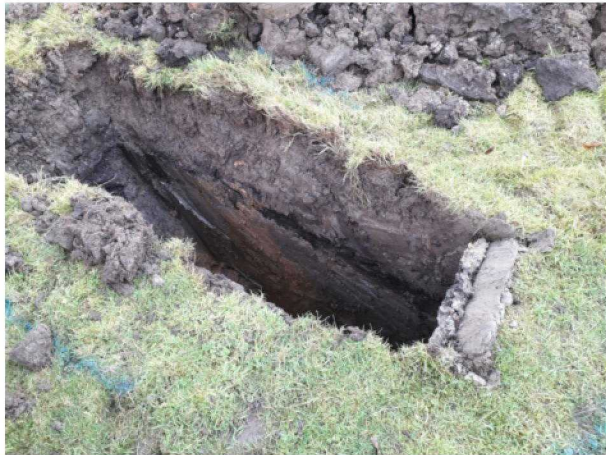
</div>											113.07	0.20	Grass over dark brown slightly gravelly slightly clayey fine to coarse SAND with frequent rootlets. Gravel is fine to coarse angular to subrounded of chalk and chert. (TOPSOIL)

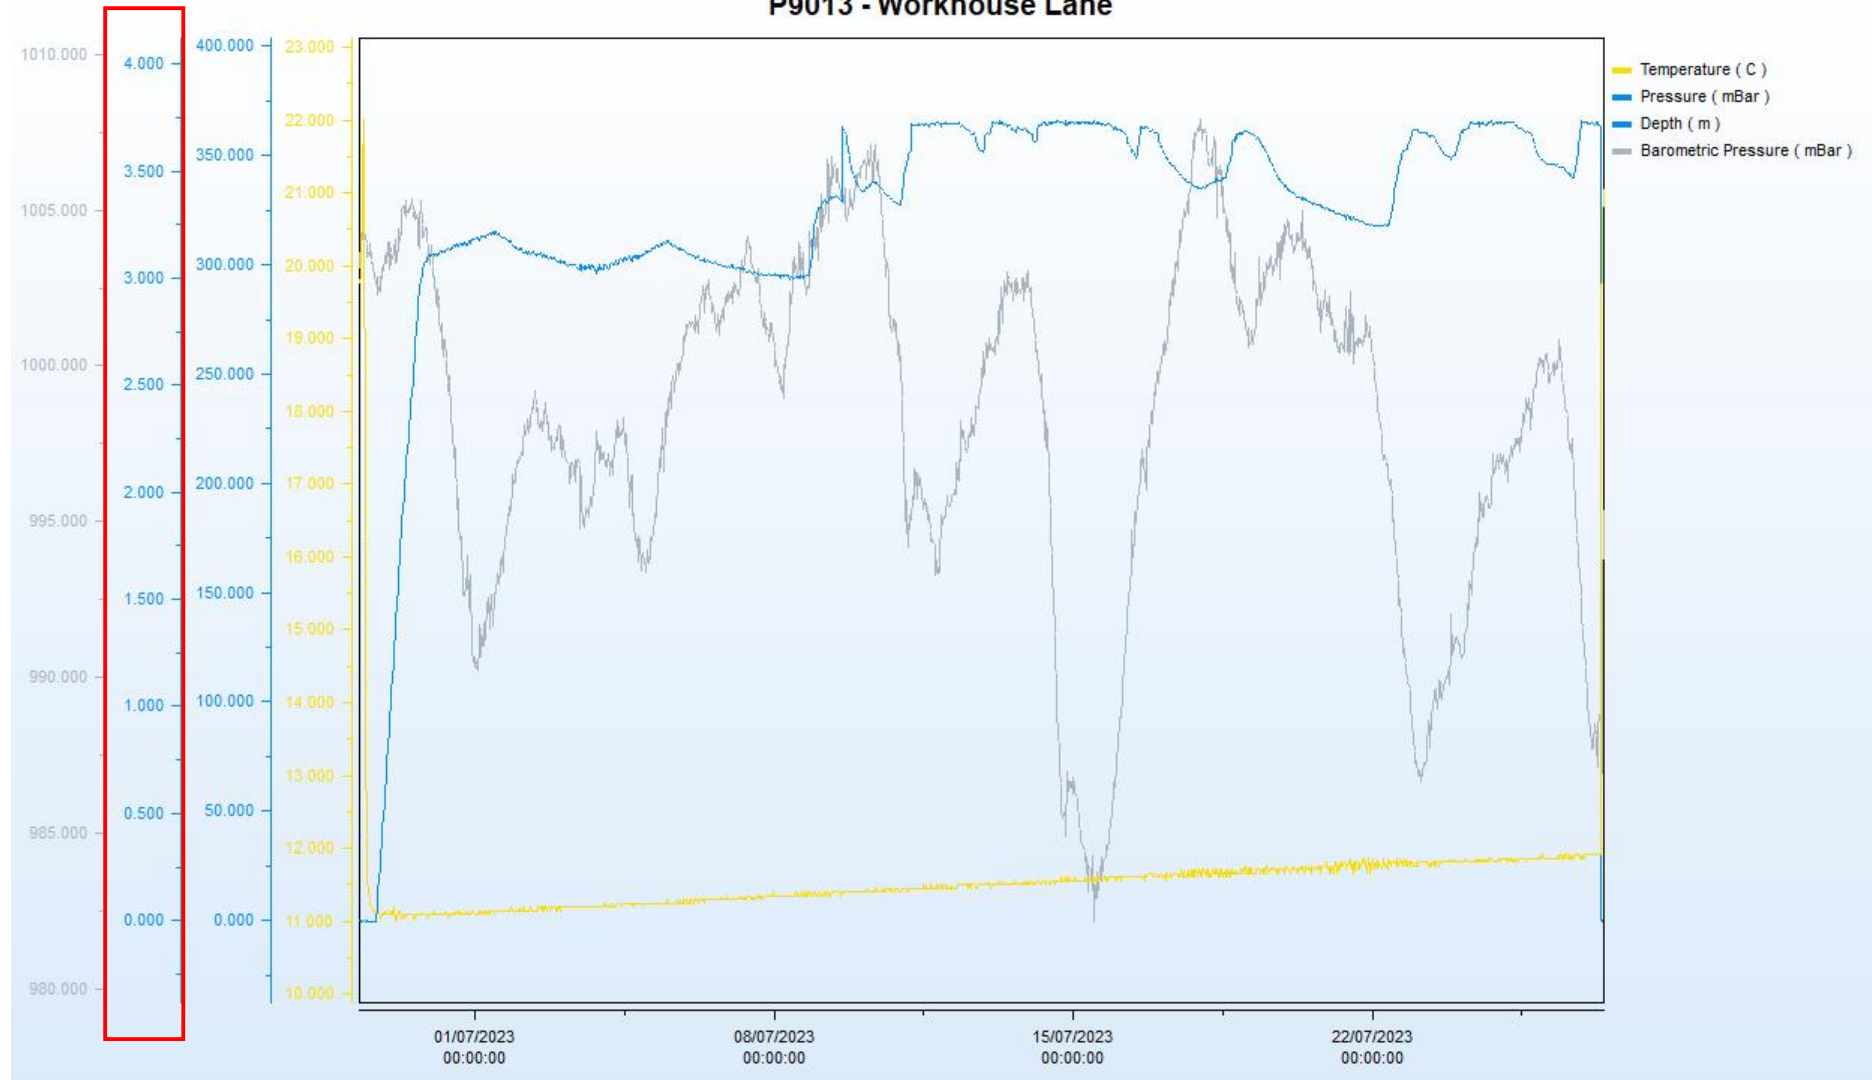
Logger K

Range on axis may change depending on range of groundwater levels.

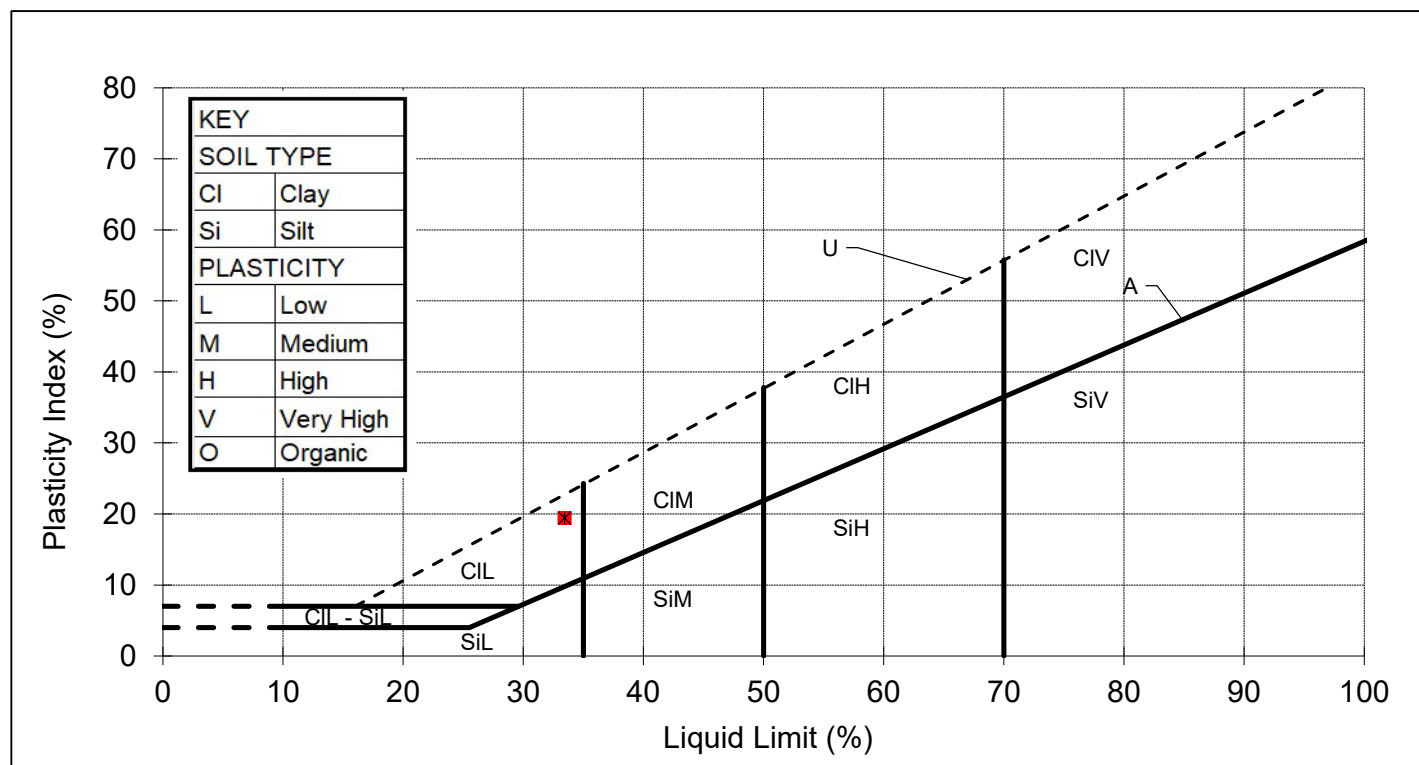
Test Readings mm (average)		Moisture Content %	Correction Factor	Correction factor from Clayton and Jukes 1978
Determination 1 (avg)	18.6	32.8	1.021	
Determination 2 (avg)	18.6	32.7

Natural Moisture Content (%)	Liquid Limit (%)	Plastic Limit (%)	Plasticity Index (%)	Passing 425 micron (%)
19.7	33	14	19	95

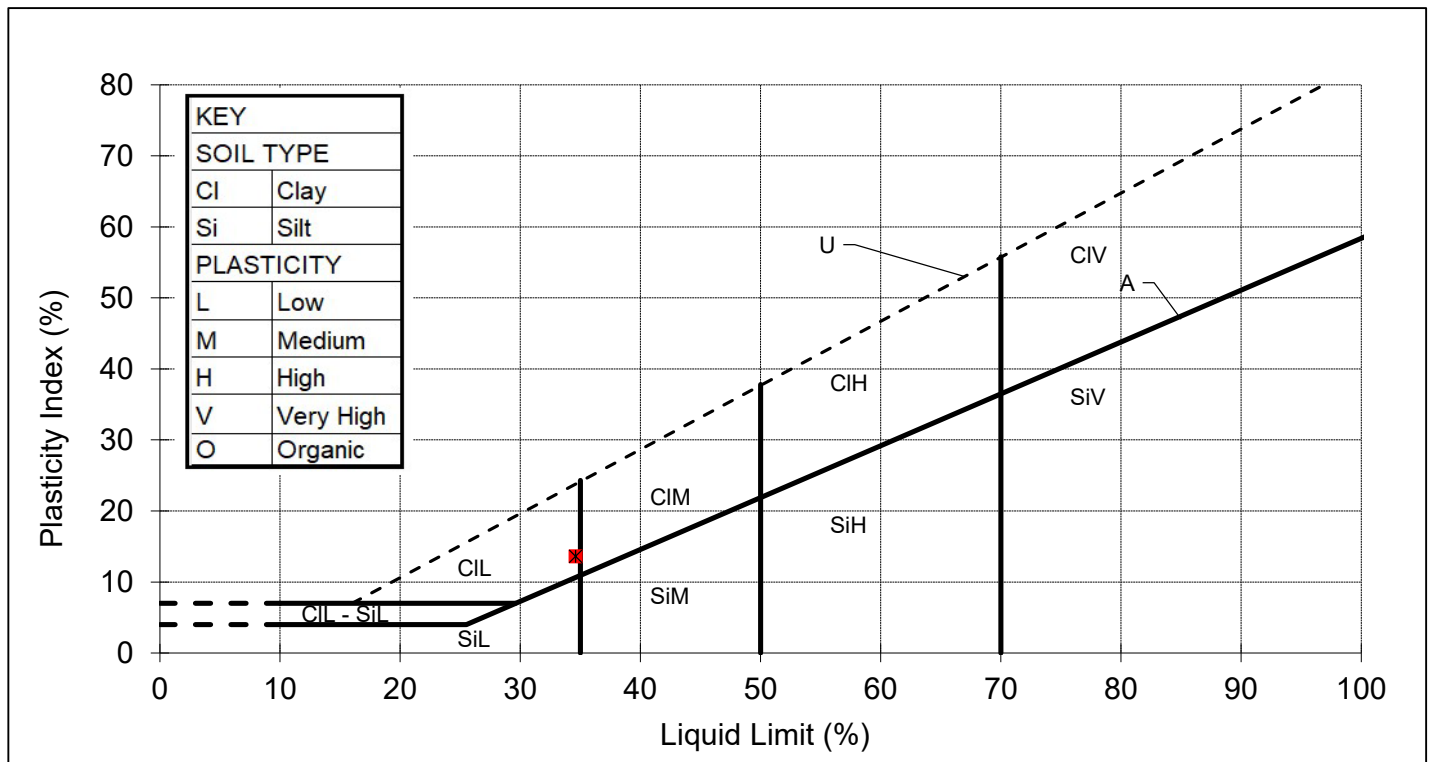
Test Readings mm (average)		Moisture Content %	Correction Factor	Correction factor from Clayton and Jukes 1978
Determination 1 (avg)	20.7	27.6	1.011	
Determination 2 (avg)	20.6	27.5

Natural Moisture Content (%)	Liquid Limit (%)	Plastic Limit (%)	Plasticity Index (%)	Passing 425 micron (%)
24.3	35	21	14	100

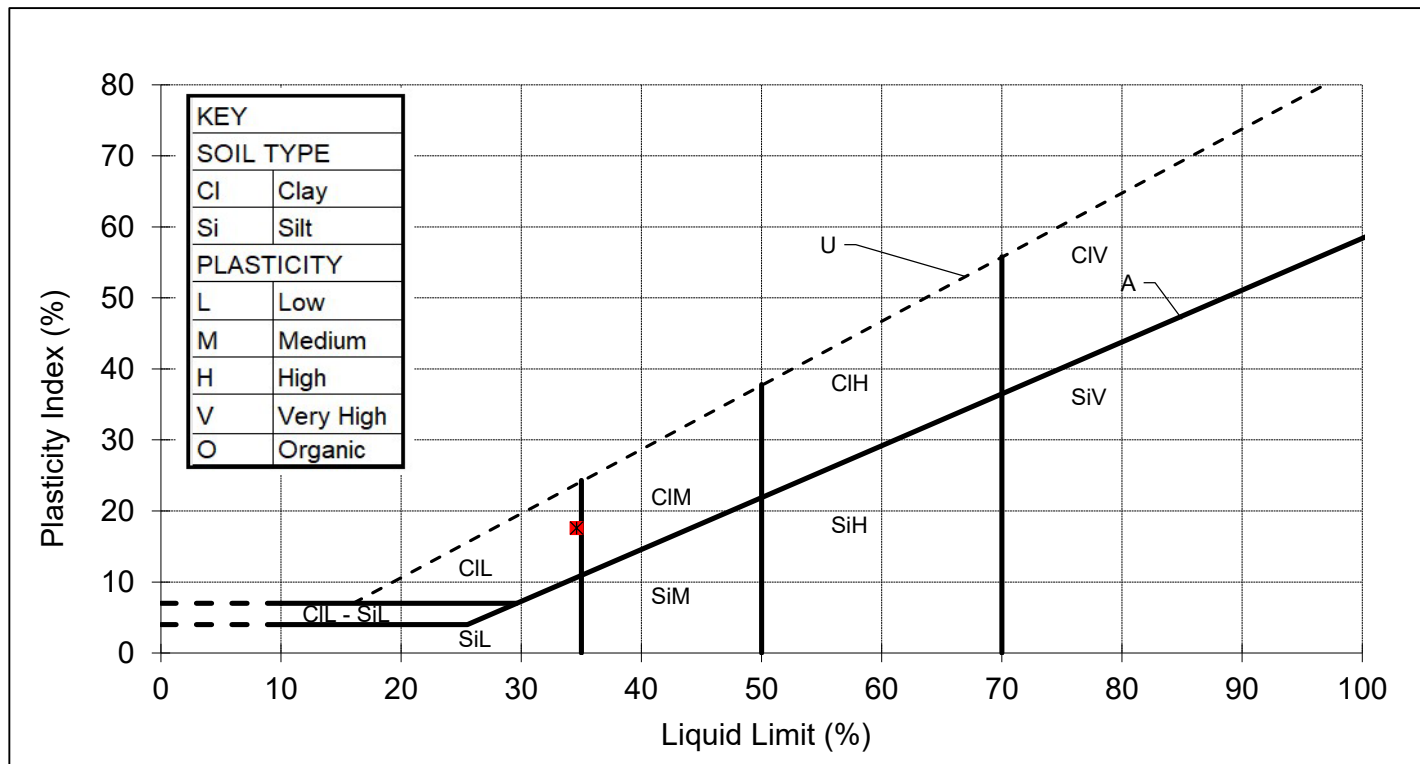
Test Readings mm (average)		Moisture Content %	Correction Factor	Correction factor from Clayton and Jukes 1978
Determination 1 (avg)	19.4	34.3	1.011	
Determination 2 (avg)	19.2	34.2

Natural Moisture Content (%)	Liquid Limit (%)	Plastic Limit (%)	Plasticity Index (%)	Passing 425 micron (%)
21.9	35	17	18	94

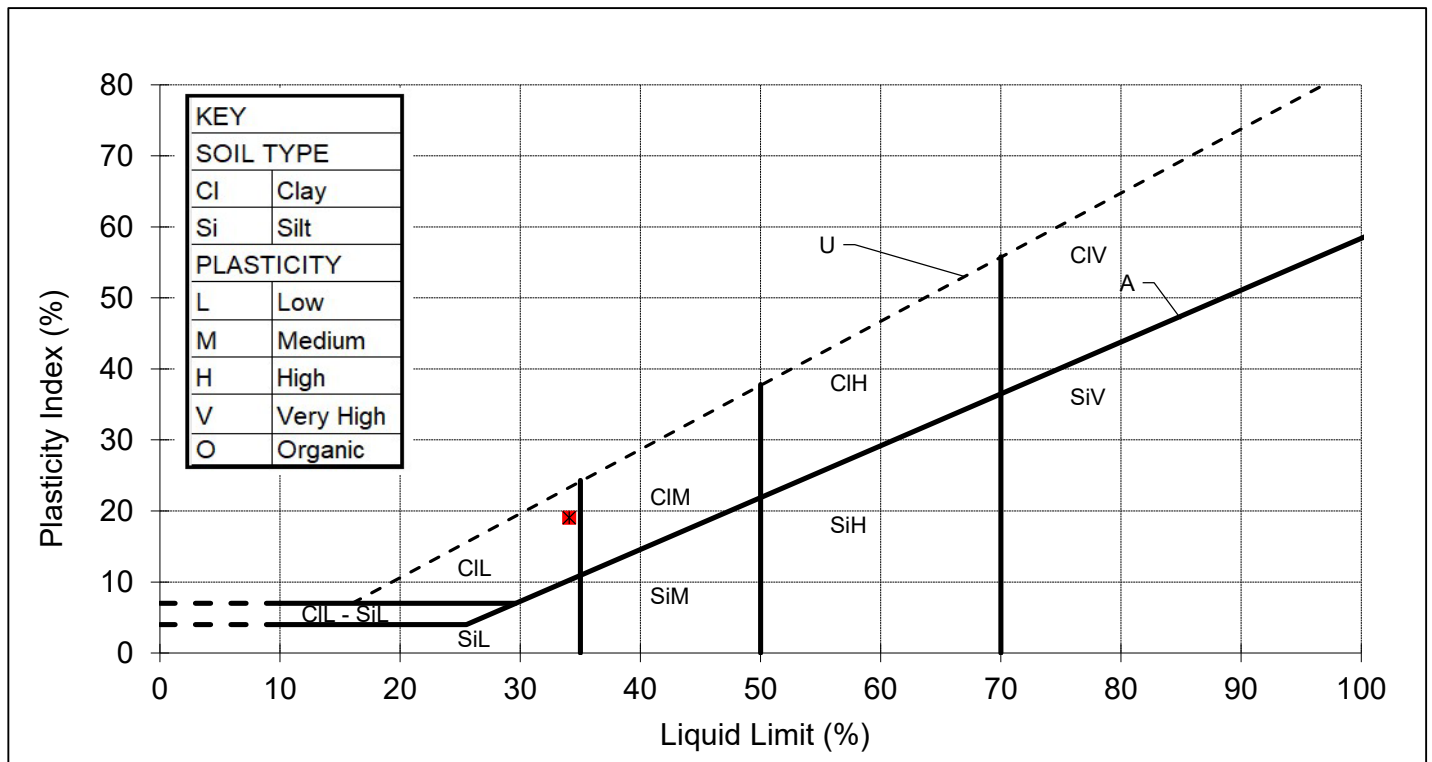
Test Readings mm (average)		Moisture Content %	Correction Factor	Correction factor from Clayton and Jukes 1978
Determination 1 (avg)	18.5	33.3	1.023	
Determination 2 (avg)	18.4	33.3

Natural Moisture Content (%)	Liquid Limit (%)	Plastic Limit (%)	Plasticity Index (%)	Passing 425 micron (%)
19.2	34	15	19	95

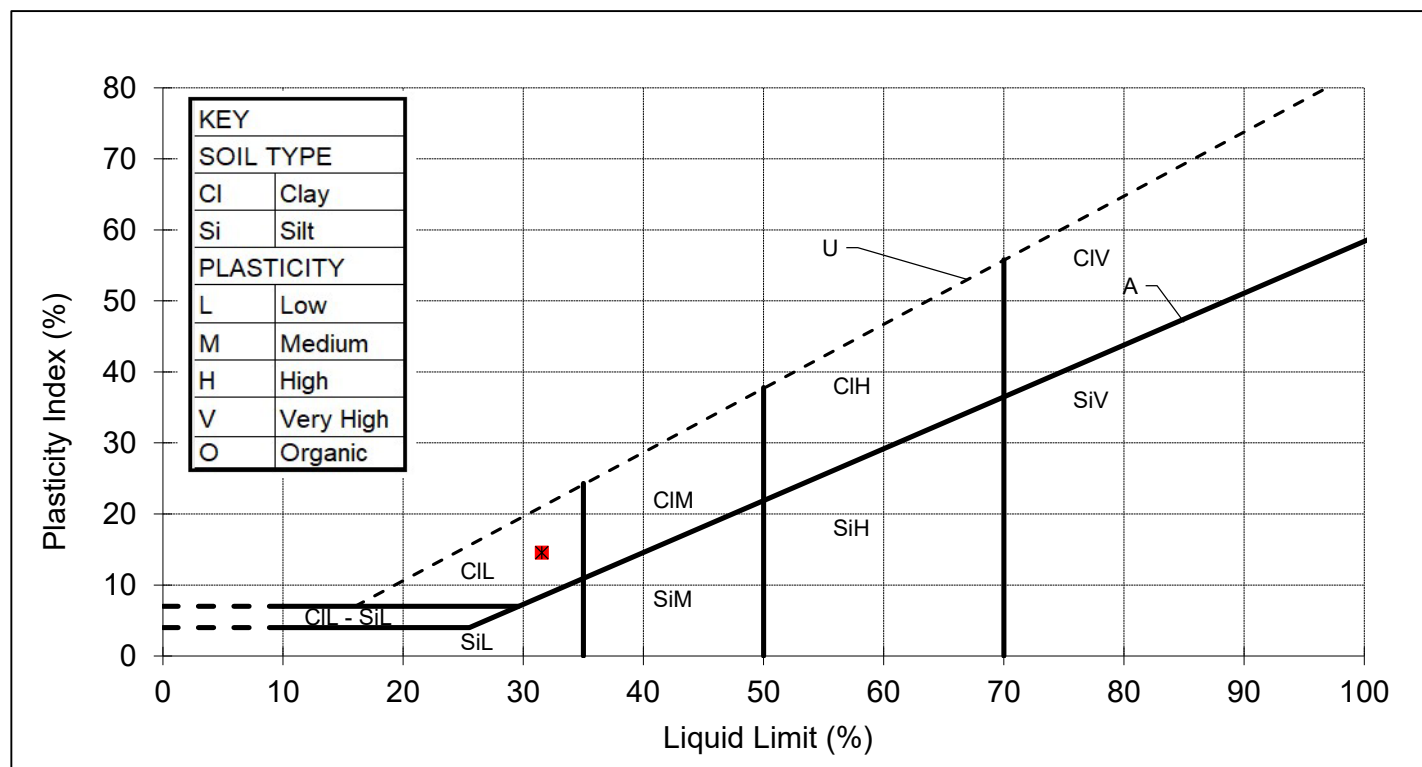
Test Readings mm (average)		Moisture Content %	Correction Factor	Correction factor from Clayton and Jukes 1978
Determination 1 (avg)	17.5	30.1	1.036	
Determination 2 (avg)	17.5	30.8

Natural Moisture Content (%)	Liquid Limit (%)	Plastic Limit (%)	Plasticity Index (%)	Passing 425 micron (%)
18.4	32	17	15	91

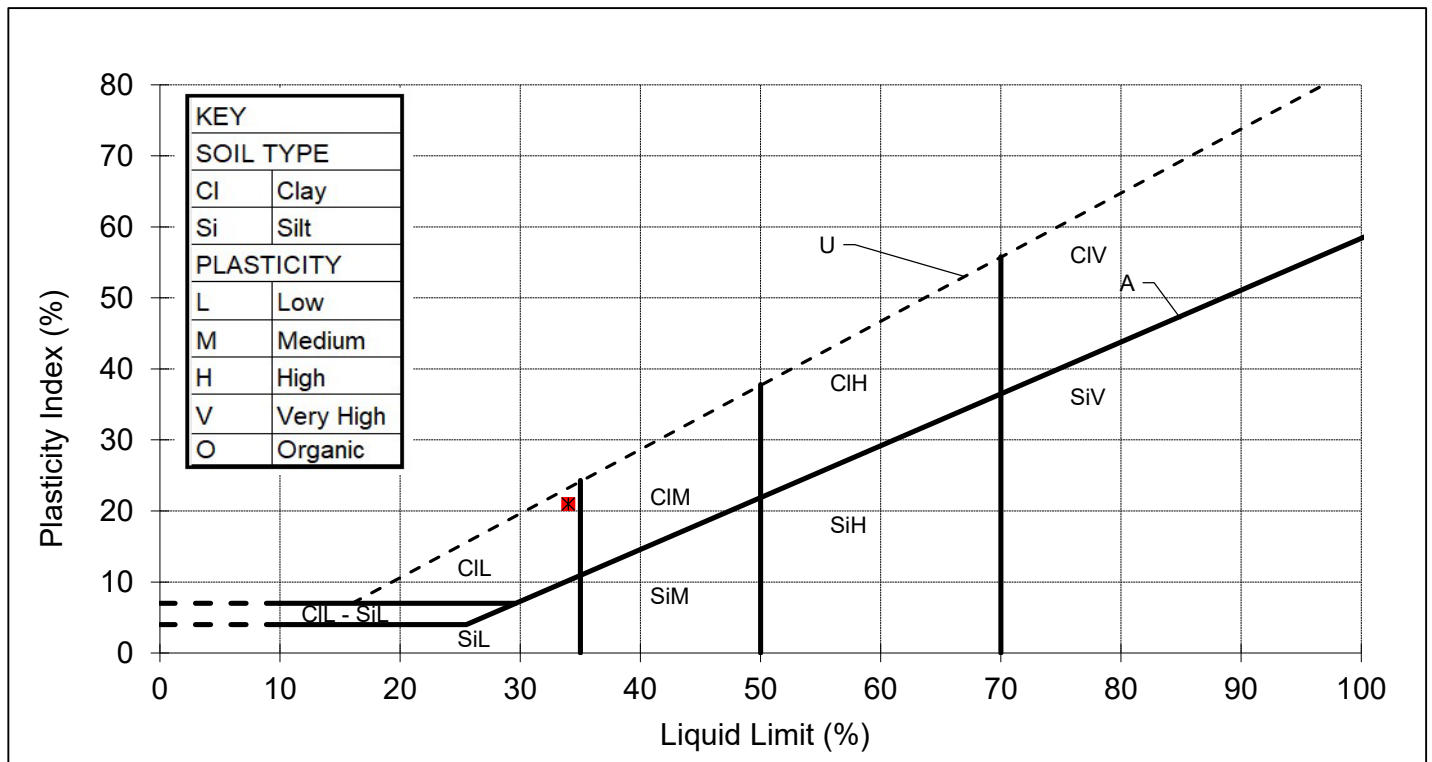
Test Readings mm (average)		Moisture Content %	Correction Factor	Correction factor from Clayton and Jukes 1978
Determination 1 (avg)	18.6	32.8	1.031	
Determination 2 (avg)	18.5	32.5

Natural Moisture Content (%)	Liquid Limit (%)	Plastic Limit (%)	Plasticity Index (%)	Passing 425 micron (%)
25.3	34	13	21	96

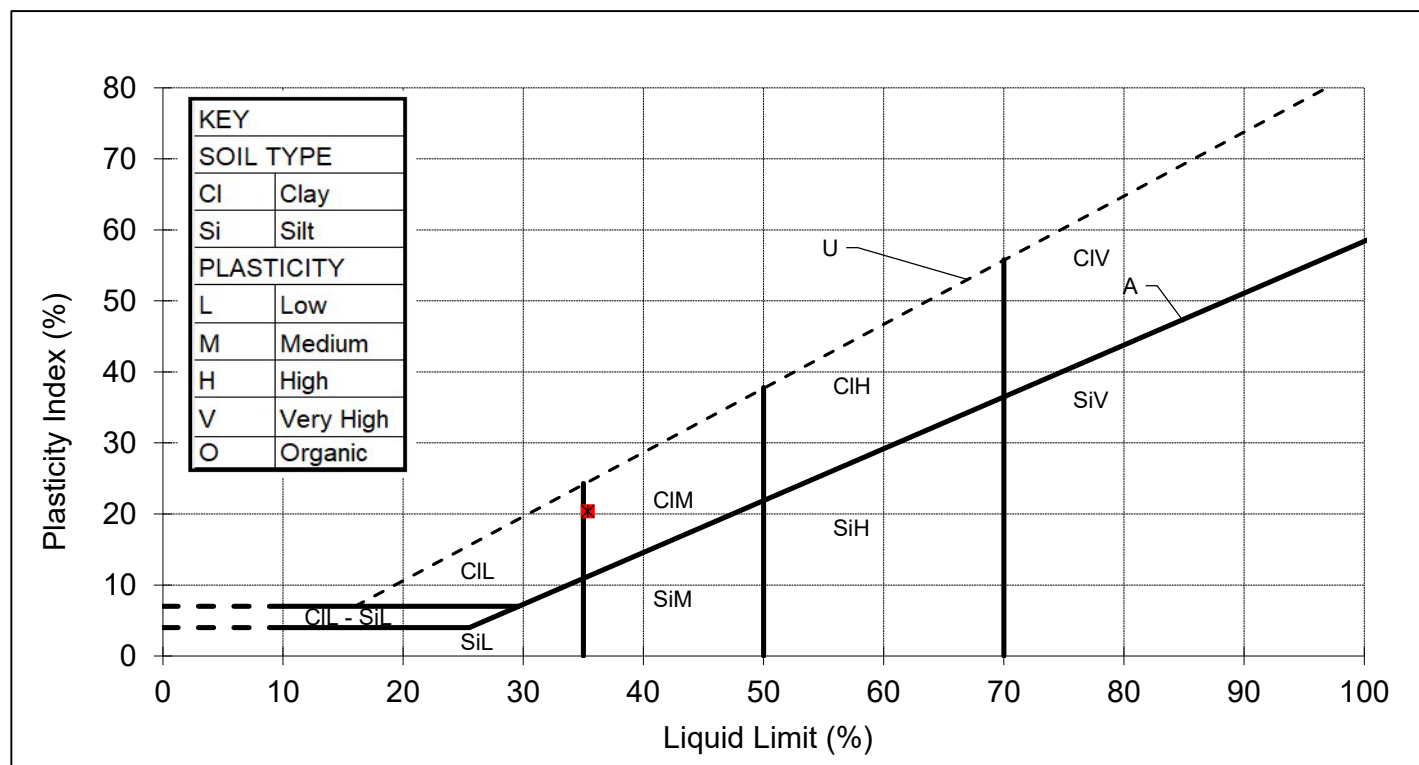
Test Readings mm (average)		Moisture Content %	Correction Factor	Correction factor from Clayton and Jukes 1978
Determination 1 (avg)	17.8	34.1	1.031	
Determination 2 (avg)	18.0	34.5

Natural Moisture Content (%)	Liquid Limit (%)	Plastic Limit (%)	Plasticity Index (%)	Passing 425 micron (%)
21.3	35	15	20	90
